The limitations of statues

By W.D. Bertelsen

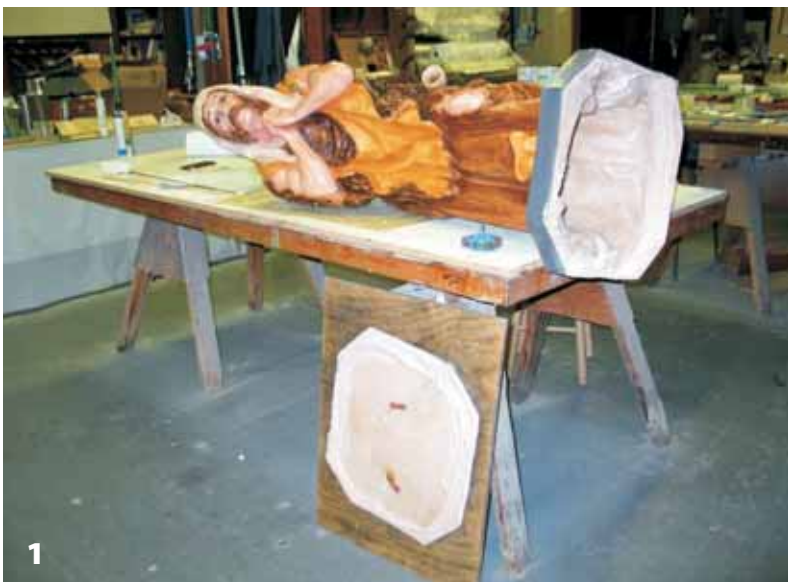
In due time, a typical Michigan winter froze Shep to the earth as if cast in concrete. A hasty post-season shove, intended to release him, instead fractured the tenuous joint between the sides of the pedestal and the bottom panel engaged by the toggle bolts. Shep had broken off all the way around the edges of his pedestal (*Photos 1 & 2*). It was not a premeditated crime. The charges were "baseless."

1 & 2— Shep after being knocked off his base.

It was clear that the base/pedestal joint needed to be redone with WEST SYSTEM® epoxy. The old polyester-encrusted base was discarded and replaced with a sandwich composite panel left over from past GBI test programs. I found an undamaged two-foot-square panel with a foam core and thick fiberglass face sheets.

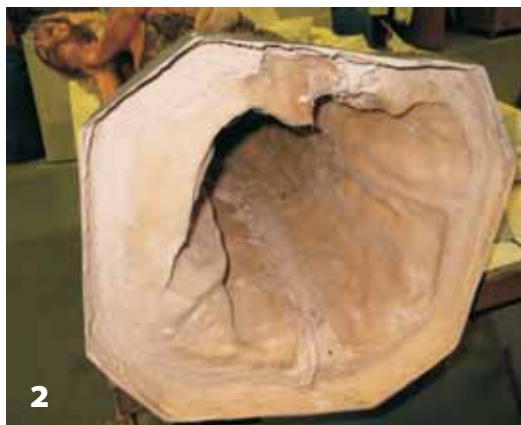
3—The gluing area of the pedestal was prepared for bonding by thoroughly abrading the surface with a wire wheel tool on a cordless drill.

In order to effect a rugged, epoxy bond to the sandwich panel, it was imperative to take full advantage of the generous surface area afforded by the pedestal sides. GBI's Tom Pawlak emphasized the need for good, pre-bond surface preparation. He produced a wire wheel tool with which to scuff the perimeter to create fresh bonding surface (Photo 3).

Thus began a series of lunch-hour work sessions. I kept at it until I got below the paint and into the glass fibers. I cleared enough width to accommodate a generous fillet of filled epoxy. The plan was to go with WEST SYSTEM 105/206 containing enough 407 Low-Density Filler to create a mayonnaise consistency, ideal for filleting.

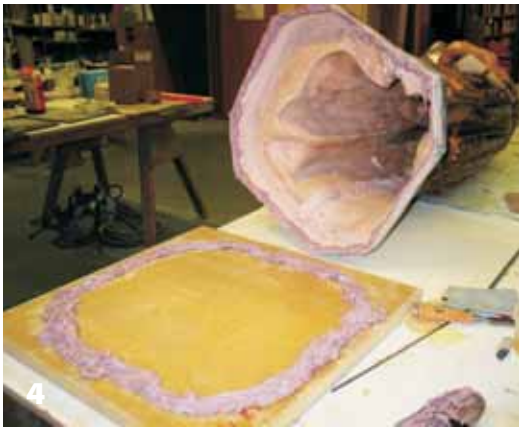
4—A bead of thickened epoxy in the outline of the pedestal was applied to the new base.

To complete the surface preparation for bonding, I used the wire wheel to abrade the textured glass surface of the new base on either side of the pedestal outline. We applied epoxy to the base and to both the inside and outside of Shep's pedestal rim (Photo 4). With the new base face up on the workbench, we lowered Shep into position and crafted the exterior fillet (Photo 5).

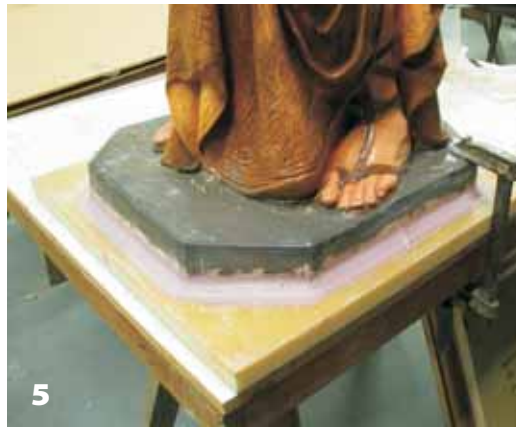
5—After the pedestal was lowered onto the bead of epoxy, a large fillet was created around the exterior of the joint

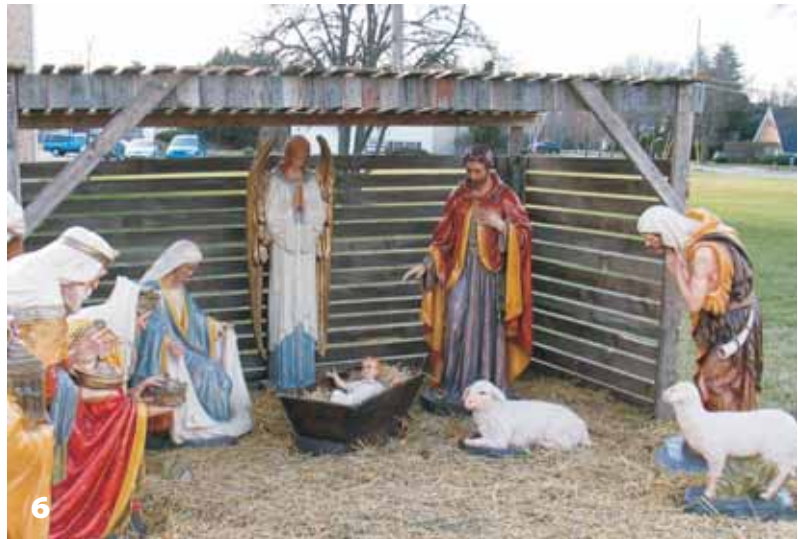
6—Shep (far right) was back on duty with twelve days to spare.

The finishing touch was to coat the foam edges of the new base with neat WEST SYSTEM 105/206. After an overnight cure, Shep was ready to return to the St. Luke's. Thanks to WEST SYSTEM epoxy, the complete display was back on line, with still twelve days to go before Christmas Eve (Photo 6). ■
