Giving *Bounty Hunter* a new skin

By Patrick Ropp

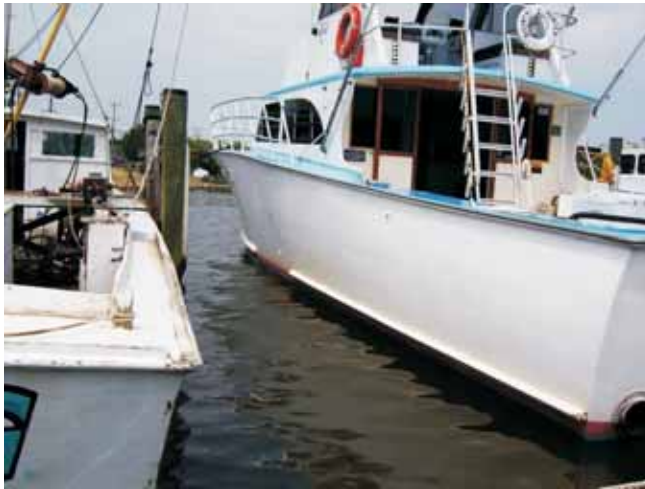
The 65' strip-planked *Bounty Hunter* after sheathing with fiberglass and WEST SYSTEM epoxy. After 5 years, she still looks as good as she did then. In addition, her new skin quickly paid for itself though increased performance.
