Repairing rotted topmasts on *Appledore IV*

By Randall Zajac

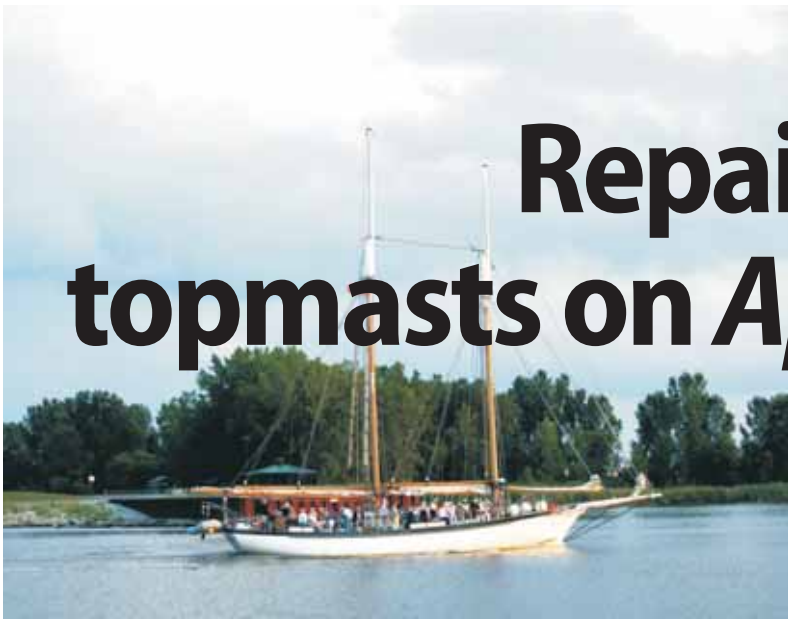
Appledore IV makes her way upriver after a cruise on the Saginaw Bay with her restored topmasts in place.

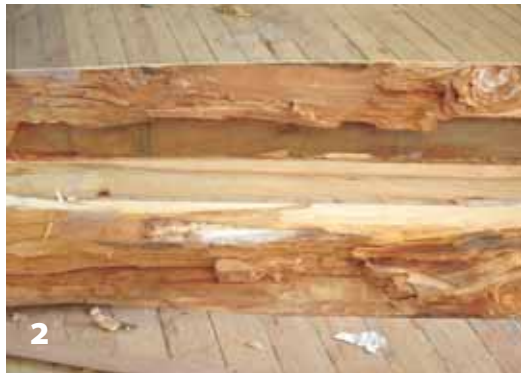
Figure 2—Once the mast was split open, the full extent of the rotted area was revealed.

Once the mast was split open, we decided that it would be better to scrap the smaller of the halves and build up the larger side. A power planer was used to get what was left of the mast down to a flat surface.

The splitting of the fore topmast involved several procedures. The first step was to use a circular saw along a batten that was nailed in place to make four cuts (two on either side of the topmast) at full depth to get the split started. A handsaw and a Sawzall™ were used to cut a bit deeper with the circular saw cuts as a guide. Wedges were then used to force any wood that was still intact apart (Figure 2).

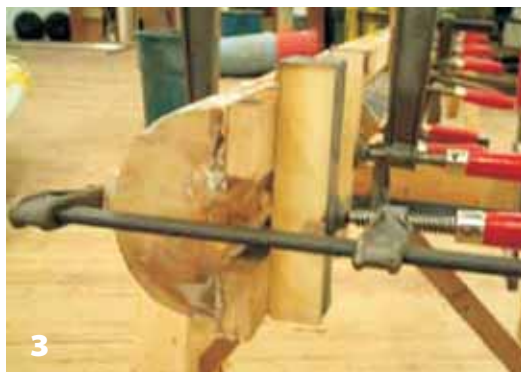
Figure 3—A 1"×2½" piece of Sitka spruce was glued to each side of the cleaned-up fore topmast half to reproduce a hollow area in the center.

The next step was to cut the pieces of Sitka spruce that were going to build the topmast back to its original shape. The mast needed to remain hollow so the first layer was two pieces of 2½"×1"×24' glued along the edges (Figure 3). All repairs were done with WEST SYSTEM® 105/206 and 404 High-Density Filler.

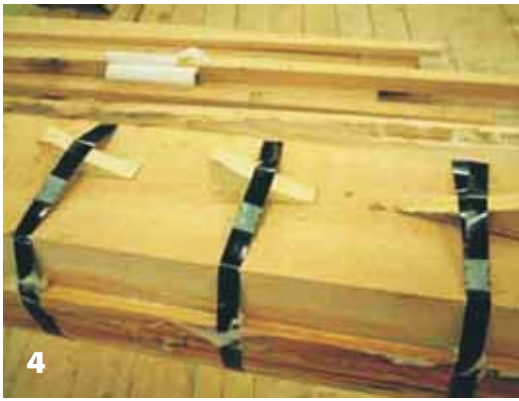
Figure 4—A 2"×8"×24' cap was clamped with metal banding tightened by driving wedges under the bands.

The second layer was a 2"×8"×24' board that was glued on as a cap. It was held in place with metal banding and tightened with wedges driven under the banding (Figure 4).

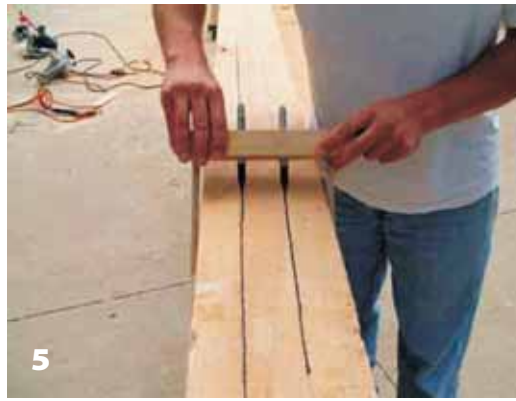
Figure 5—A spar-making jig is used to lay out the flats of an octagon on a square, tapered spar. The lines are guides for planing the corners.

Once the epoxy was cured and the clamps were removed, the repair area was cut down with a power planer to match the original taper of the topmast. A spar-making jig was used to lay out the flats of an octagon on the squared portion of the topmast (Figure 5). These lines were used as guides for planing off excess stock.

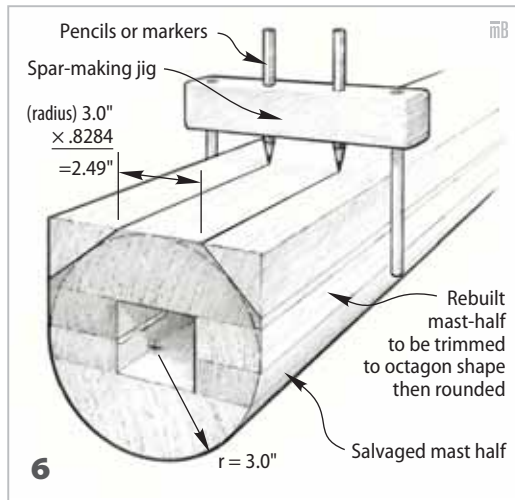
Figure 6—Dimensions of a spar-making jig. Multiply the spar's radius by .8284 to get the width of one side of an octagon.

the narrowing width of the spar. To make a spar-making jig, space the dowels at the biggest diameter of the spar. To find your pencil spacing, multiply the largest radius of the spar by .8284 (radius × .8284) (Figure 6).

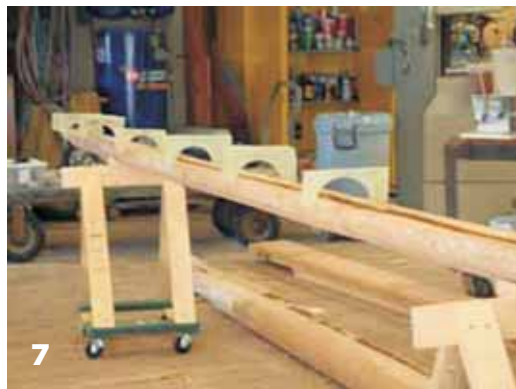
The main topmast had a bad section of rot near the bottom that would need to be replaced with solid wood. The fore topmast was much worse. It had an entire board in the middle that was rotted and would have to be cut apart to be repaired.

Figure 7—A circular saw, chisels, and a rabbet plane were used to excavate rot in the main topmast.

The rot in the main topmast was excavated with a circular saw, chisels, and a rabbet plane. A jig was made to cut the taper into the mast for the repair. It functioned as a ramp to raise the saw blade out of the wood as it went down the line. A piece of Sitka spruce was made to fit into the cavity (Figure 8) and epoxied in place.

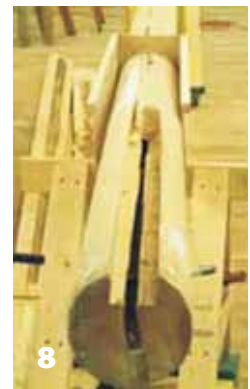
Figure 8—The excavation was prepared to receive a custom Sitka spruce Dutchman.

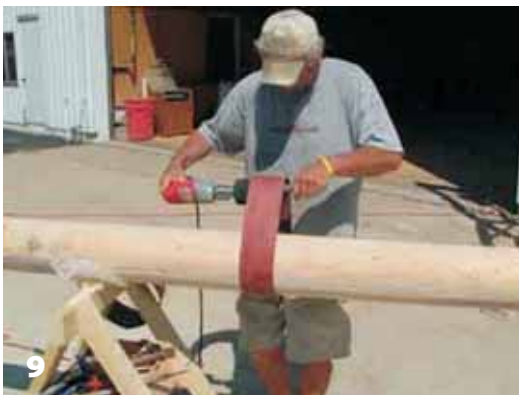
Figure 9—Bill Bauer finish sands a mast. A sanding belt was placed on a drill with a rubber drum to get the final rounding.

Any cracks, knots, or small sections of rot were cut out and filled with thickened epoxy. A belt sander was then used to knock down any high spots. To get the final rounding, a sanding belt was placed on a drill with a rubber drum (Figure 9).

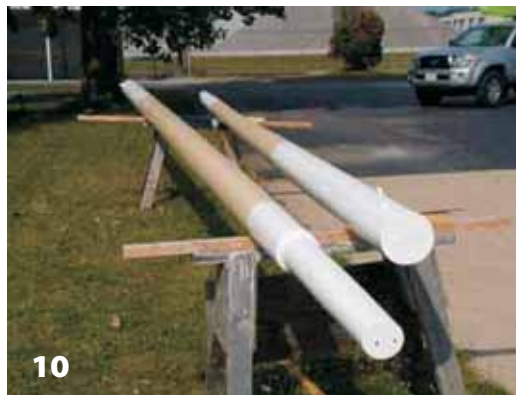
Figure 10—The repaired masts received 2 coats of 105/206 followed by a couple of coats of paint.

Once everything was fair, the mast received 2 coats of 105/206 before being painted with marine enamel (Figure 10). ■
