Plastic engine cover repair

By Jeff Wright

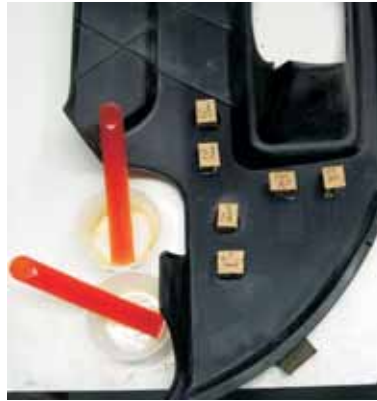
I first prepared all six areas and then glued simple 3/4" x 3/4" blocks of 3/4" plywood to the surface with the plywood veneers parallel to the surface (1). After a 24 hour cure, I used a set of large pliers to twist the blocks off (2). If the adhesion is good it would shear the plywood, but if the adhesion is poor the block will just snap off. This simple test provided very useful data as shown in the following table.

1—Test blocks glued to the underside of the cover.

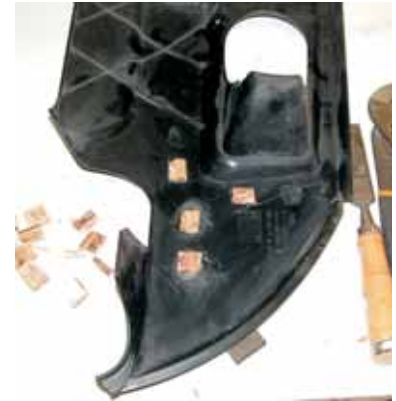
Testing surface prep for plastic adhesion		
Adhesive	Preparation method	Results
G/5	None	Poor
	Sand with 80-grit sandpaper	Good
	Flame treat	Poor
G/flex 655	None	Good
	Sand with 80-grit sandpaper	Good
	Flame treat	Good

2—The test showed which combinations of glue and prep worked best.

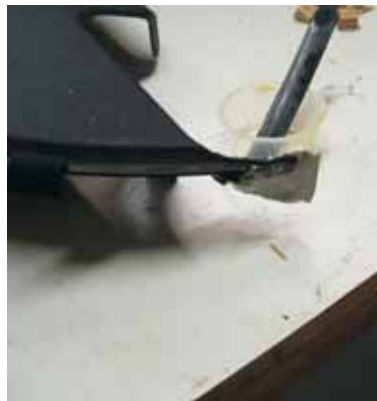
3—Fixing the broken tab with G/flex 655 and flame treating.

Since the area I had to repair would be difficult to sand and the joint did not fit together tightly, I decided to use flame treating and G/flex 655. I used duct tape to hold the small tab in position (3). It was easy to remove the tape after the epoxy cured. I was then able to install the cover back on the engine just like before it was broken (4). ■

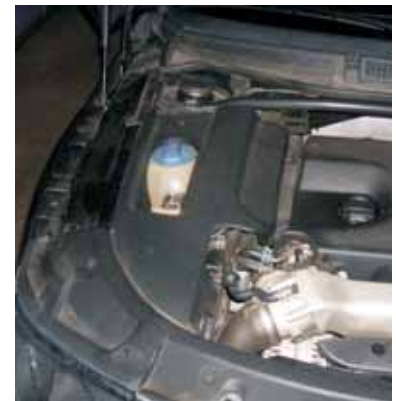
4—The repaired cover back in place in the Audi.
