The difference between a carbon fiber bicycle frame repair and wall art

By Randy Zajac

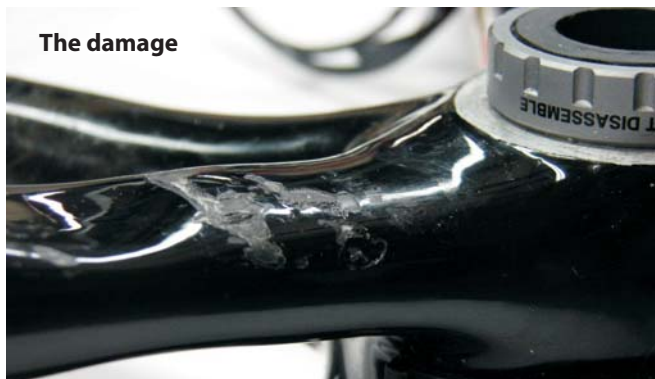
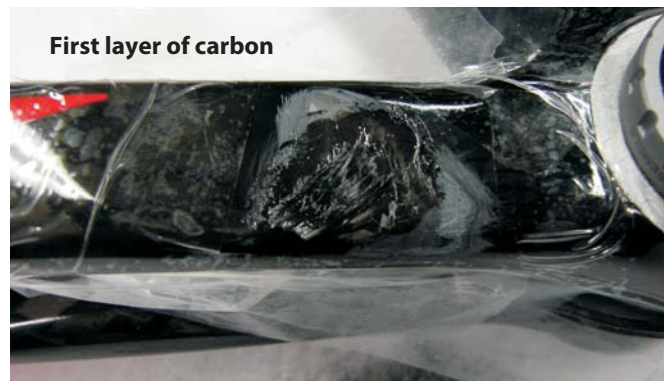
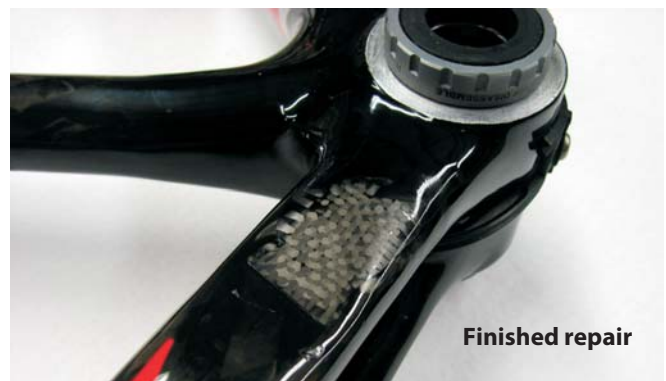
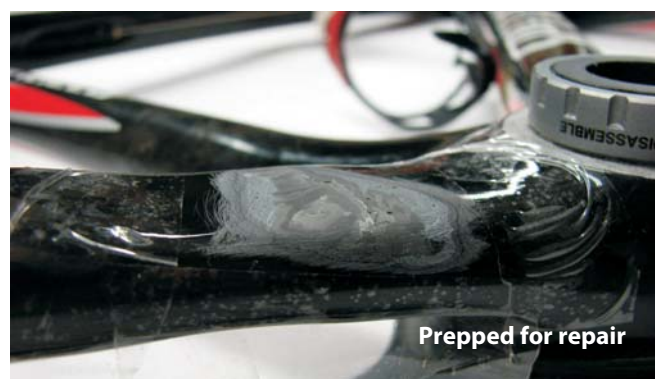
Bike #1 – Carbon Fiber Specialized® Tarmac

A good friend of mine who works at a Specialized bicycle shop in Saginaw, Michigan asked if I could repair a frame with chain stay damage caused by a customer-tuned front derailleur. After seeing the damage in person, I knew the frame was sound and definitely repairable. There was no major impact with hidden damage; it was simply a matter of replacing carbon fiber that had been ground away by a dropped chain.

The first step was to sand down the area by hand, taking note of any fibers and the orientations as I went until I reached good laminate. Luckily, this area had quite a

thick layer of filled resin for cosmetic reasons and the damage barely went into the first layer of structural carbon fiber. I started the rebuilding process for the first layer using strands of carbon fiber oriented in the right direction laminated with WEST SYSTEM® 105 epoxy Resin®/205 Fast Hardener®. Although difficult to determine accurately, I estimated a 100:1 scarf ratio based on material removed. After this first layer cured, I sanded the area to take down any high/rough spots.

To take the place of the filled resin, I used a layer of 5.7oz/sq yd woven carbon fiber fabric. I used clear packaging tape both to mask the rest of the frame and get the fabric to lie down as smoothly as possible. Once this cured, I sanded it fair, blending it to the rest of the chain stay and polished it as it is a cosmetic, sacrificial layer.

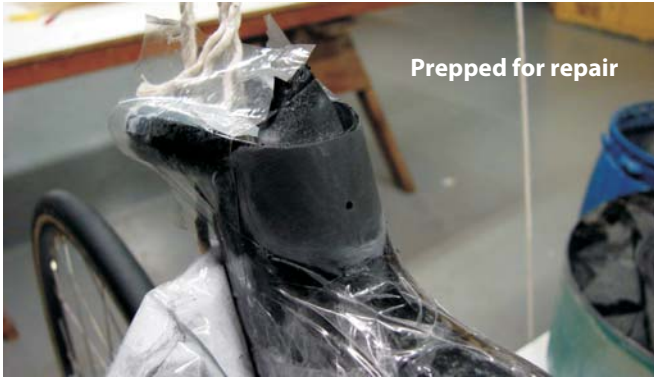
Shortly after I repaired the Specialized frame, I had an opportunity to repair a track bike. The owner had over torqued the seat post bolts, causing the front of the integrated seat post clamp to split. Once again, the damage

was not caused by an impact and it was clear how far it went into the frame. To make it easier to work on, I hung the bike from the ceiling as there wasn't a round tube I could clamp into my bike stand.

Prepped for repair

To start, I carefully drilled a crack stopper hole to prevent it from going any further. I then sanded the area and prepared it for bonding. I used 105 Resin/205 Fast Hardener with 703 Unidirectional Carbon Fiber Tape to reinforce the seat clamp in three layers/steps. I let the epoxy cure and sanded it fair between layers to better control the final shape. Once the final layer was on and shaped/faired, I prepped for paint. I covered the repair with two coats of black one-part polyurethane paint.

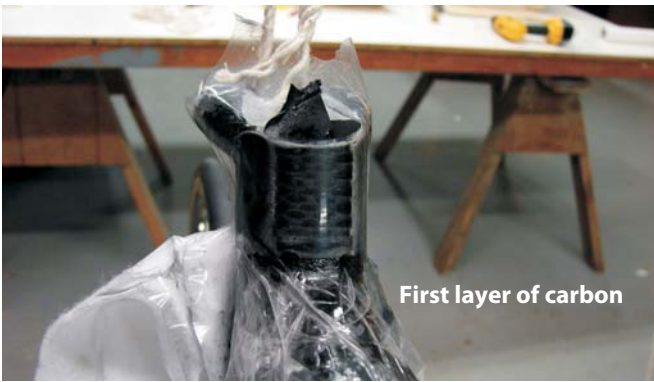
First layer of carbon

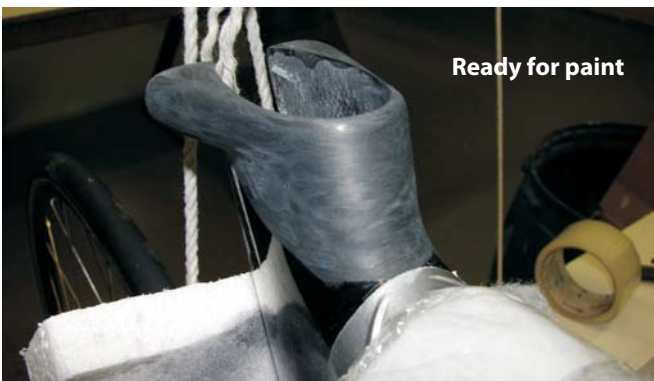
Ready for paint

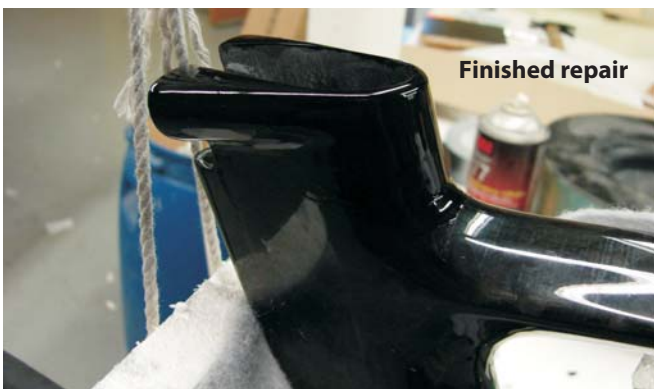
Finished repair

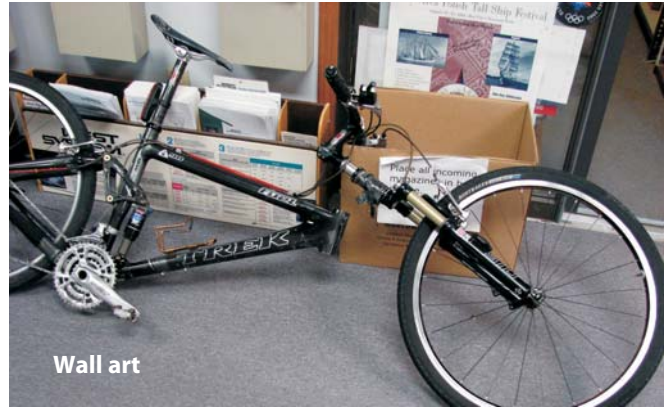
Bike #3 – Carbon Fiber Trek Fuel 98™

Wall art

This is an example of a frame you would not want to fix, but hang on your wall. I was riding home, a block from my house, and was hit by a minivan whose driver was looking over his left shoulder instead of around the corner where he was going. The frame collapsed under me with fractures at multiple points along each tube. Because this damage goes throughout and was caused by impact, it is highly unlikely that it would be a sound fix.

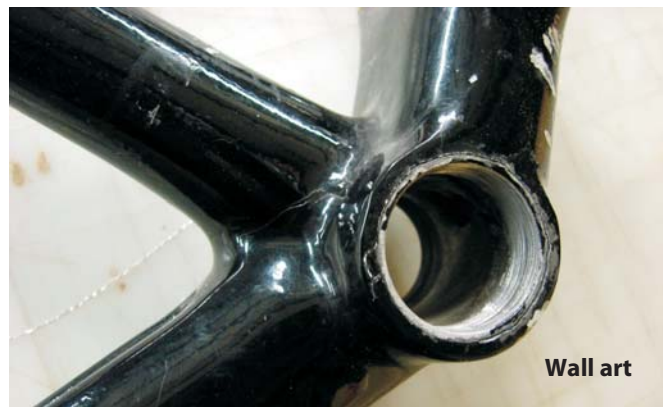
Bike #4 – Carbon Fiber mountain bike

Wall art

This is a frame that a friend of mine was riding for a few months. The design of the frame and the fact that he is a bigger guy lead to the bottom bracket shell breaking away from the laminate and causing a crack to form. This is one of the gray areas as the frame is repairable but not worth repairing. If it was a good design, lightweight, or a responsive part I would consider it, but this was one of the worst composite frames I have ever ridden. Bottom line: wall art. ■
