A Magnesium Crankcase Repair

By Rob VanMullekom

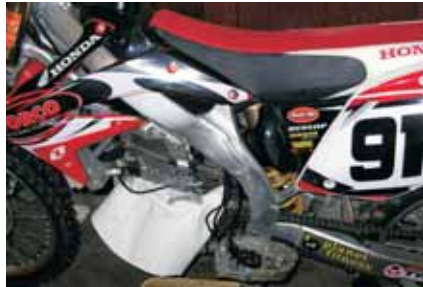
I work here at Gougeon Brothers, Inc. as Operation Supervisor in the epoxy department where we do production mixing, assembly, packaging and quality control of the epoxy products. A lot of the guys I work with here ride motorcycles. In talking with these guys, I found out that it is not uncommon to punch a hole in the ignition housing cover. In fact, that's what happened to my bike.

▲ The holed ignition cover is off the bike, but still connected to it.

There were too many wire and cable connections so, rather than disconnect these, I chose to do the repair with the cover in suite. After draining the oil, I cleaned all surfaces with acetone. Then I abraded the surfaces of the magnesium with

a Dremmel™ Tool, to knock off the burs. Crankcases are made of other materials; aluminum and steel and I think the same strategies would work as well. I figured a rivet-like casting of epoxy would hold best. So I wanted the epoxy thick enough so it wouldn't run out.

I chose Six10® mixed with a little 420 Aluminum Powder because it will not sag and also is toughened a little so it will tolerate the vibrations that the whole motorcycle is exposed to. I didn't need enough to use the static mixer so I simply dispensed some into a small plastic container and stirred it. This material is thin when moving but thickens, or gels, when at rest. So it was easy to work into the void and flow about the inside to form my vision of a rivet. I smoothed over the outside and allowed it to cure for 24 hours before I filled the case with oil.

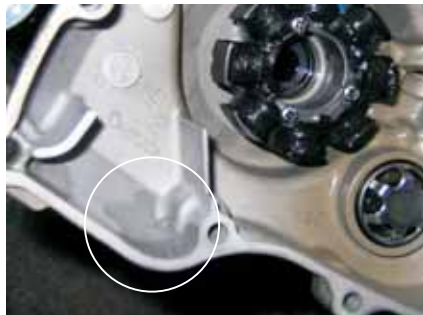
▼ The repaired cover showing the repair area from the inside.

When I'm done riding the bike I put it in the garage with a paper towel under the repair so I can easily note if there are any leaks. Since the repair, I've ridden about 16 hours and have had no leaks. ■
