Flying Dutchman Repair

By Bill Bauer

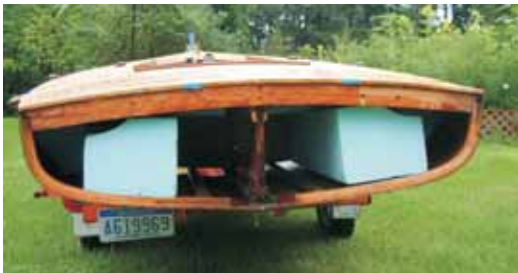
The remaining part of the transom was removed to reveal a nice solid frame.

First I removed the remaining portion of the transom. The original builder made the transom sacrificial; it was fastened with small brads through the hull and glued to a frame. The only screws in the transom were those holding the gudgeons.

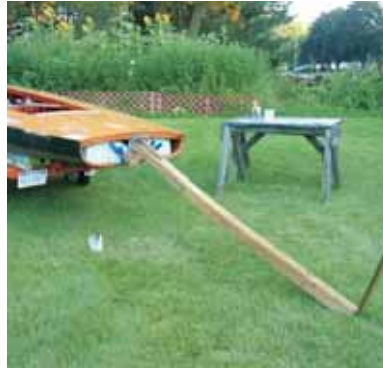
Left—The transom gusset clamped with a handy 4 × 4.

The old gudgeons had vertical mounting holes and the new ones had horizontal mounting holes so I installed a wider transom gusset.

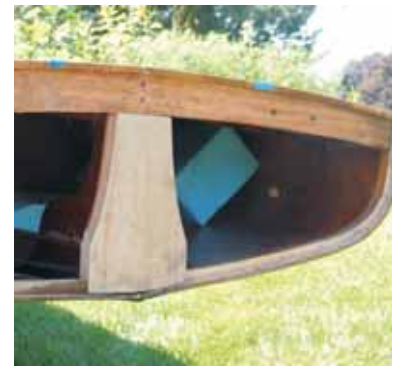
Right—The newly shaped gusset glued in place.

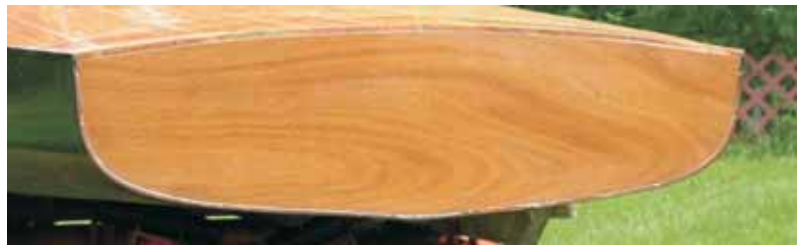
The new transom glued in place, ready for new gudgeons and a new aluminum rudder.

The original transom was 9 mm mahogany plywood, the new one is 7 mm with 6 oz glass on the inside and 4 oz glass on the outside coated with several layers of WEST SYSTEM 105 Resin®/207 Special Clear Hardener™.

The transom was the glued in place with 105 Resin/205 Fast Hardener® thickened with 404 High-Density filler.
