# EPOXYWORKS®

BUILDING, RESTORATION & REPAIR with EPOXY  
Number 54 ■ Spring 2022

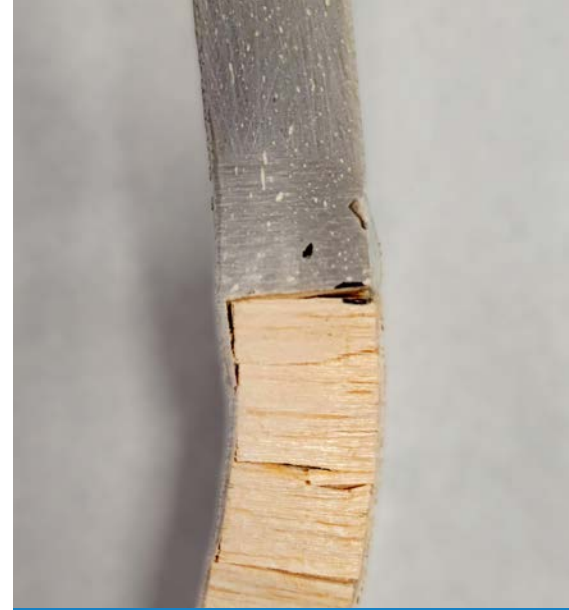
Another sample panel that broke at the repair joint was the one with thickened WEST SYSTEM Epoxy as the core replacement. Its fiberglass and balsa core fractured right at the transition from epoxy to balsa core. This break happened exactly where I thought it would; I just imagined it was going to be a more dramatic break than it actually was.

*Close-up of the epoxy filled repair. Its fiberglass and balsa core fractured right at the transition from epoxy to balsa core.*

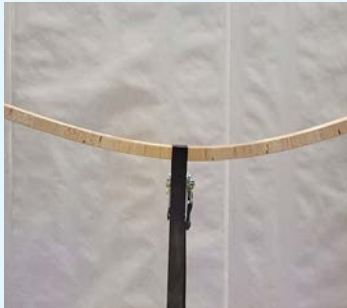
The control sample panel with the all-balsa core just folded and cracked in half when it broke, because of the concentrated area of bending or loading. The others all broke at the edge where the balsa core met the alternate core material and fractured the fiberglass on top in compression.

*The balsa cored control sample cracked in half when it broke.*

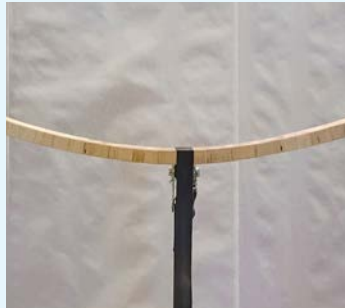
*The pine repair broke where the balsa core met the pine.*

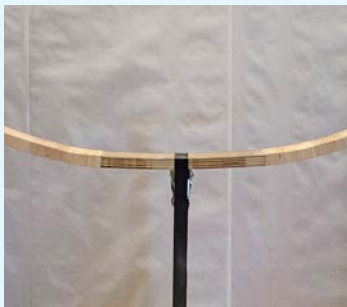
*The plywood repair broke where the balsa and plywood met.*

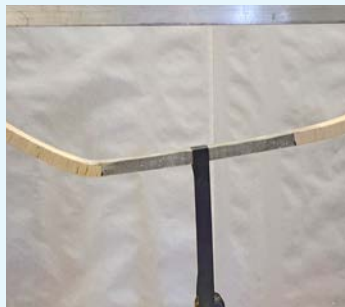
*The epoxy filled repair broke most dramatically, again at the repair joint.*

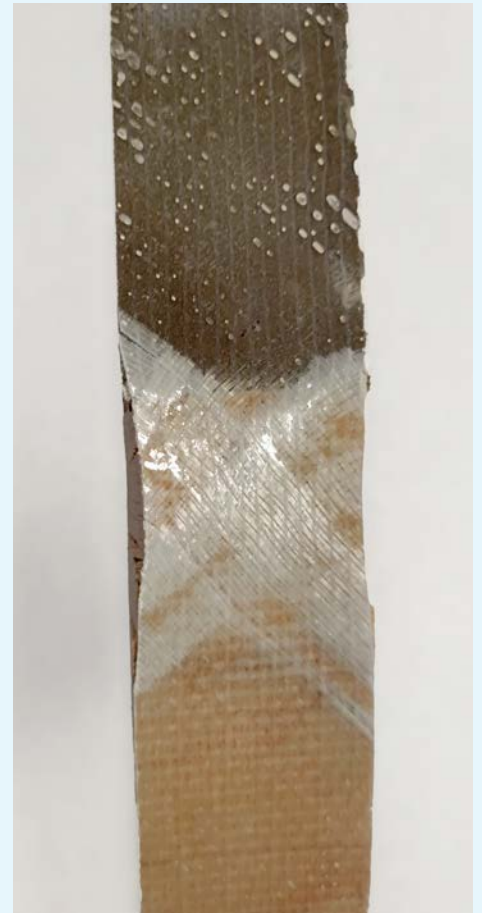
*The fiberglass fractured in compression at the transition from epoxy to balsa core in the epoxy-filled repair.*

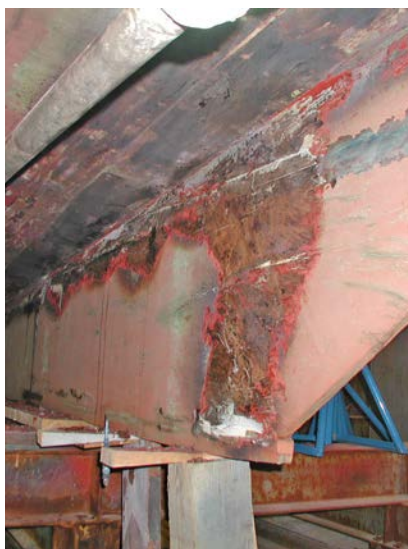
*1989 keel check with epoxy repairs still good.*

These defects were mainly the result of poor performed repairs. The era of the previous repairs could be identified by shipwright techniques and material types. But the repairs Rick Ryan had made in 1989 with WEST SYSTEM Epoxy were still holding strong in 2000.

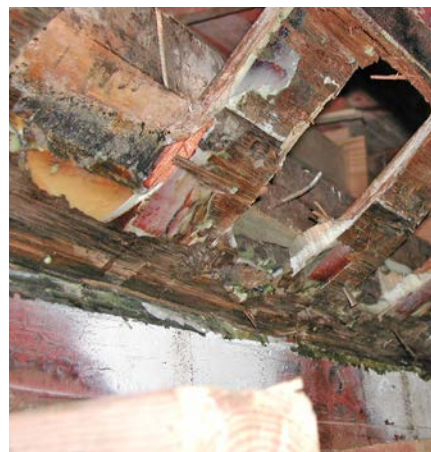
*We shored up the boat under the hull for support. Initially, we removed the garboard, first, and second strake planks before starting the first stage of the rib repair. Using a chainsaw, we cut out the keel in 2' sections, and then installed a plywood mock-up of the new keel.*

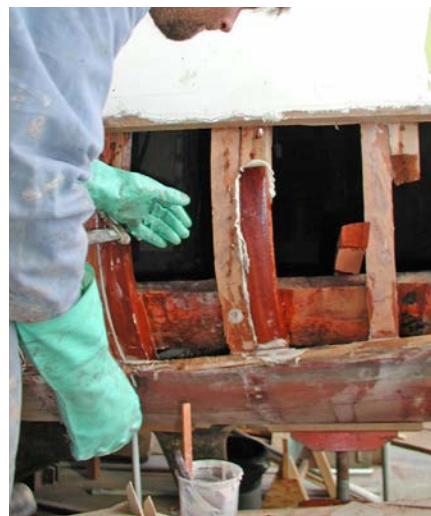
*With every rib in the boat inspected, we used mahogany laminate strips and epoxy to repair the ribs. We used laminations to repair the bilge stringers where they were inaccessible under the bulkheads. Longer, accessible stringer sections were repaired with new boards and long scarf joints with epoxy. Where stringers had oversized holes caused by bolt corrosion, we double plugged the holes with epoxy and installed a new silicon bronze bolt.*

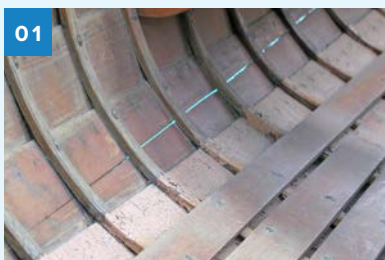
01

On the truck to Seattle, *BO-PEEP II*'s tender had suffered split planks in both bilge turns. The planks were also checked and had long gaps, rendering the tender unseaworthy. I made a uniform cut in each long split to clean out the damaged wood and inserted double overlapping graving pieces (sometimes called a Dutchman) with WEST SYSTEM 105 Resin®/205 Fast Hardener® thickened with 404 High-Density Filler.

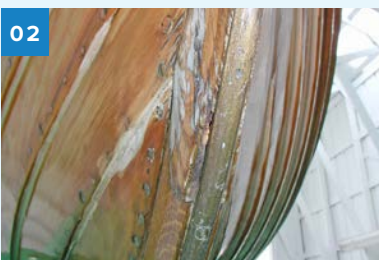
02

The original iron bolt in the oak stem had corroded and rotted the wood causing more small checks in the area. I carefully cut out the bad wood with a drill and chisel. Only a small amount of good wood remained, leaving the mortise in an irregular in shape. I used several small blocks of wood like a three-dimensional jigsaw puzzle to fill this void. When the thickened epoxy cured, I shaped the repair and installed a 316L stainless steel bolt.

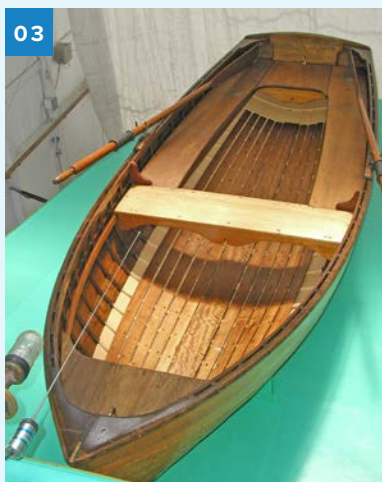
03

There were small checks in the planks joining the transom and keel. The keel had minor grounding damage. I simply reefed the checks slightly with my pocketknife and filled them with WEST SYSTEM 105/205 thickened with 404 filler.

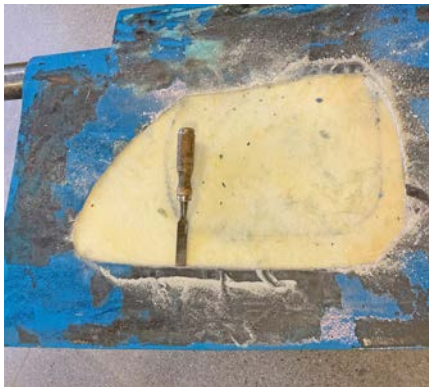
We found two smaller delaminated spots on one side of the rudder and a sizeable one on the other, along with a 6" crack near the rudder shaft. After drilling a few  $\frac{3}{8}$ " drainage holes through the fiberglass skin and into the foam core, we saw that it was still in good shape even though the foam was wet.

*Fiberglass removed from a section of the rudder.*

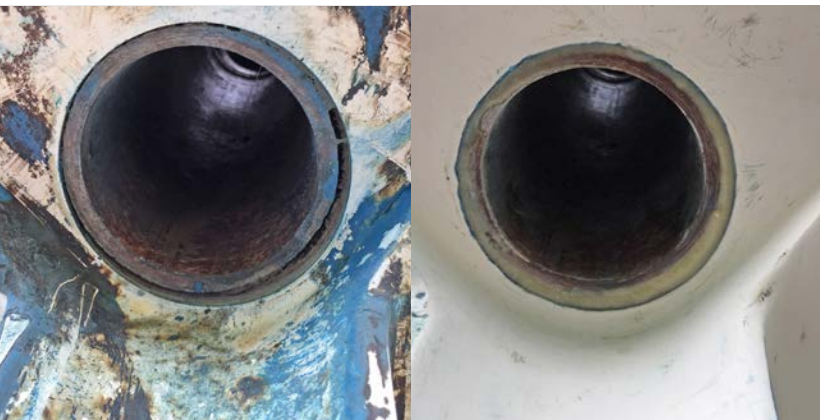
**TOP:** The rudder shaft before and after repair.

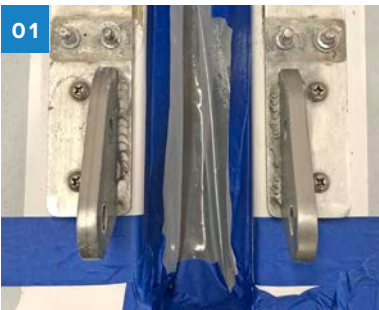
*The aluminum mounting brackets on the mast step.*

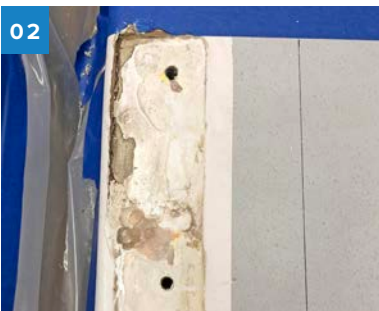
*The aluminum brackets were removed to evaluate the damage.*
