# EPOXYWORKS®

Number 19 ■ Spring 2002

## Testing large bonded-in fasteners

By Brian Knight

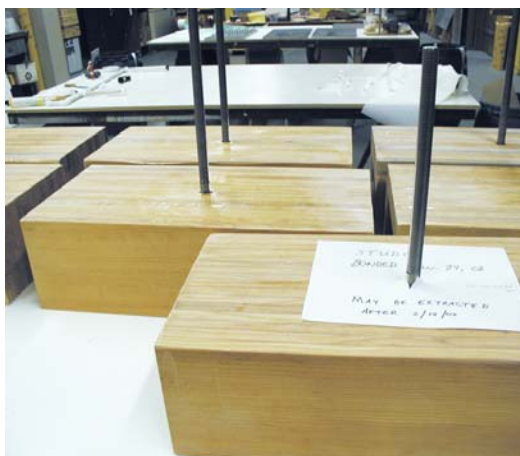
The 3/4" diameter stainless steel bolt test samples before the test. In these samples, the rods were imbedded parallel to the glue joints.

(Although the boat's hardware will be fastened with bolts, for the tests we used threaded rods of the same diameter and material.)

For the tests on the 3/4" stainless steel rods, we built seven laminated wood blocks, 12" x 24" x 5 1/2" thick. All were laminated 3/4" clear Douglas fir. The photo (top) shows how the bolt was oriented relative to the grain of the wood. We drilled one " diameter hole into each of these samples and bonded a rod in the center of each

hole. Two of the rods were imbedded 5" deep and five rods were imbedded 6" deep.

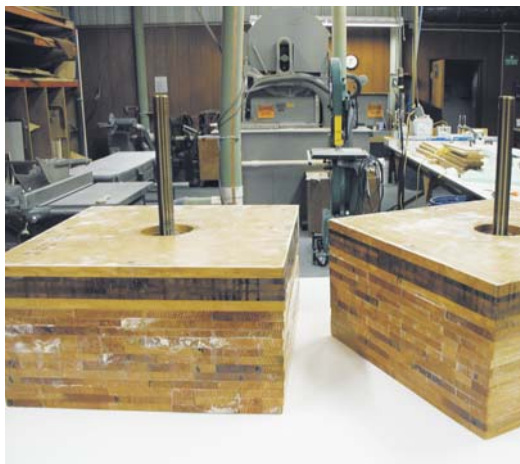
The 1 1/2" diameter silicon bronze bolt test samples before the test. In these samples, the rods were imbedded perpendicular to the glue joints. The top six laminations represent Scheherazade's outer skin over a heavy laminated frame.

Additionally, Lloyd's requested two more tests on the much larger 1½" silicon bronze fasteners that would be used to hold the propeller strut to the bottom of the hull. The force required to extract these fasteners was expected to be very large (50,000 lb+), so we increased the size of the panel to 24"×24"×12" thick. The wood grain is oriented differently in this test than in the ¾" rod test (*middle photo, previous page*). This reflects the way the grain is oriented in the hull of the boat. Each fastener was bonded into a 1" hole drilled 9" deep.

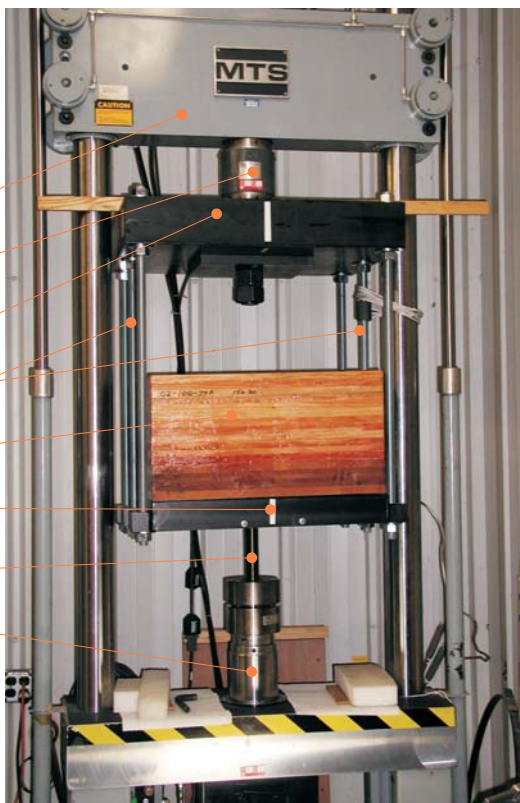
The MTS test machine with the test apparatus and 1 1/2" silicon bronze bolt test sample before the test.

- Test frame crosshead
- Load cell
- Monolith
- 1" steel rods
- Test block
- Frame
- 1 1/2" bronze rod
- Test machine actuator

The end of the bonded-in fastener is threaded into a socket on the actuating cylinder on the base of the test machine. The test is performed by pulling the bonded threaded rod downward out of the wood block. We knew that we needed a very substantial method of holding the wood sample up while the fastener is withdrawn from it.

The wood block is held in a "steel angle frame. The frame is suspended by six 1" threaded steel rods attached to a wood/steel composite slab just below the top of the steel frame. The slab is a 4½" thick plywood core sandwiched between two pieces of ¼" steel, bonded together with epoxy, and nicknamed "the Monolith" (from the movie *2001: A Space Odyssey*). The Monolith is anchored to the crosshead of the MTS Test Frame with a 2" diameter bolt. At the very top of the test apparatus is the cylindrical load cell, which measures the force the machine is exerting on the fastener.

It is not an easy thing to hold onto a piece of wood and pull on the other side of it to the tune of more than 50,000 lb, but that is exactly what we hoped our apparatus would do. Between the frame, the six steel threaded rods, the Monolith, the 2" diameter bolt, the 1½" silicon bronze threaded rod, and a test machine with a pulling capacity of 100,000 lb, something has to go. We hoped it would be the epoxy joint or the wood, not the fixture or the test machine.

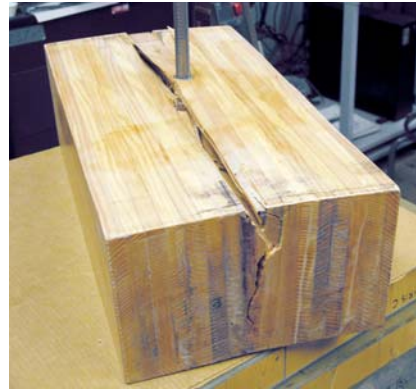
In the smaller, ¾" rod tests (*left and middle*), with the rod imbedded parallel to the glue joints, the damage looked quite different than it did in the larger 1½" rod test (*bottom*), with the rod imbedded perpendicular to the glue joints. The quality of the wood in the samples also varied between the two tests.

In both tests, the machine's travel limit was set to 1", so the rod remained partially imbedded in the block.

It took an average of 22,000 lb of force to remove the ¾"×6" embed, 19,400 lb to remove the ¾"×5" embed and 55,000 lb of force to remove the 1½"×9" embed silicon bronze rods. The force required in pounds per square inch

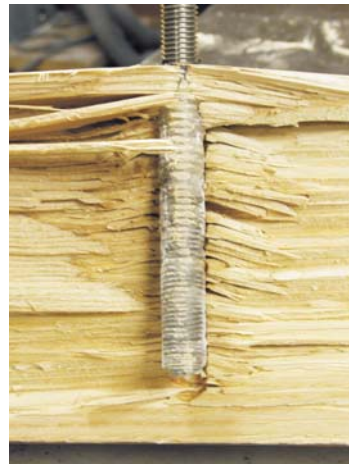
A tested 12"×24"×5½" sample was split apart after a test. This sample had a large crack running the complete length of the sample after the test had finished (*above*). I drove a wedge into the crack which split the block the remaining distance. The photo (*left*) shows how the wood adjacent to the threaded rod was destroyed—graphic evidence of the forces exerted during this test.

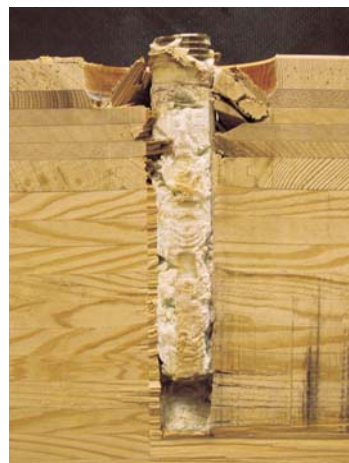
A tested 24"×24"×12" sample was cut apart on a large band saw so we could examine what happened in the area around the bolt. The photo (*left*) shows that the wood was permanently deflected around the bolt. You can see the distortion in the glue line where the wood was bent in the direction of the bolt movement. The wood fiber closest to the bolt is distorted more than the fiber farther from the bolt. This is the result of the wood compressing near the bolt and crushing. Farther away from the bolt, the distortion becomes less noticeable until, a few inches from the bolt, there is no visible deflection. ■
