Fence construction revisited

By Brian Knight

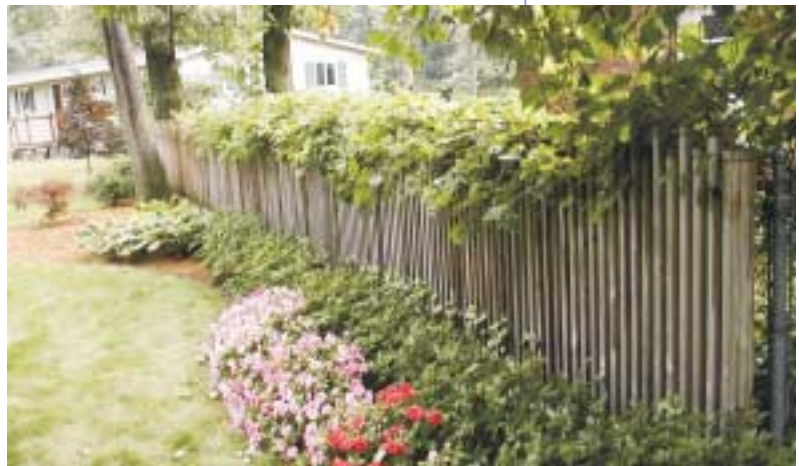
Every now and then it is good to look back at a project to see how it has held up over several years. To the right are photos of the western red cedar fence I built in the summer of 1998 and below is the fence as it looks today. This fence uses no nails, screws, bolts, etc. to hold it together. Only WEST SYSTEM® epoxy holds the spindles to the rails and the rails to the posts. Now after five years of Michigan summers and winters, I can attest that there is no rot in the fence nor have any of the spindles fallen off. There is no finish on the wood so it has weathered to a dirty silver color.

Above—The jig used to build the fence and the fence just after completion. **Below**—The fence as it appears today.

I reasoned that if there were no holes, there would be little rot. So far this has been the case. One additional trick I used was to coat the fence posts with epoxy—not all over—just a stripe one foot or so wide where the post enters the ground. This is where fence posts rot and break because this is the point where the post is continu-

ously in contact with moist soil and also has oxygen available. Above this stripe, the wood is able to dry out and does not rot. Below this stripe, the wood stays wet, but there is not enough oxygen to support the growth of the rot fungus so the wood cannot rot there either. By coating the post with epoxy in this area, I reduced the amount of oxygen and moisture able to enter the wood, and, so far, no rot is evident.
