A quick fix to a broken spinnaker pole

By Meade Gougeon

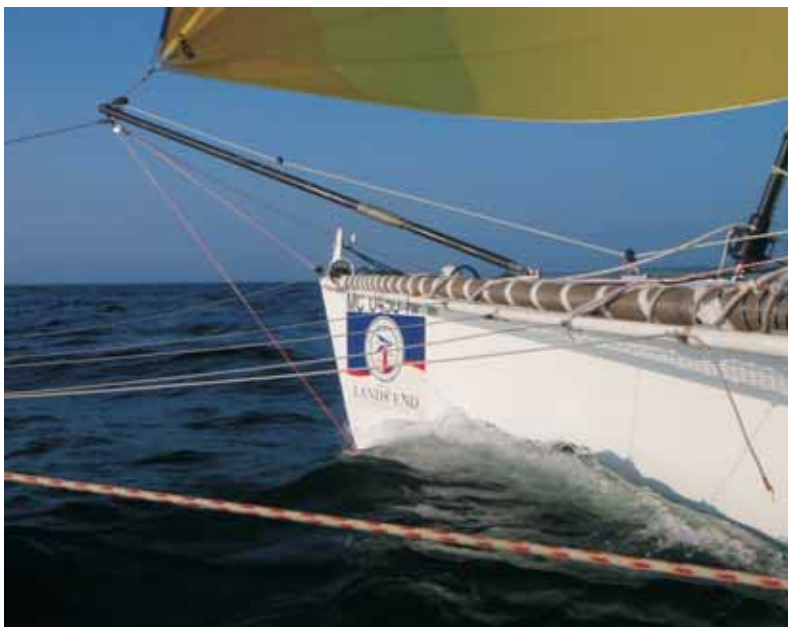
Within five hours of the breakage, the modified epoxy blend had cured on the pole splice. With the spinnaker pole fully restored we were back in the race.

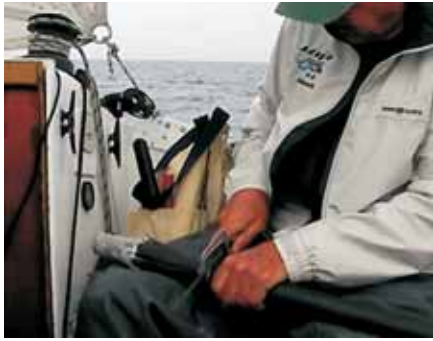
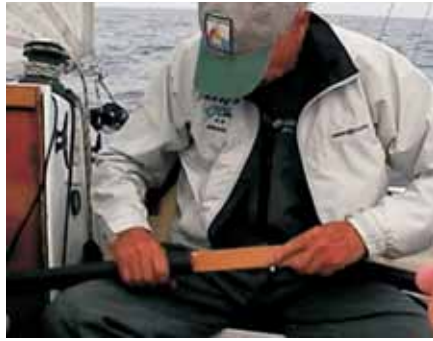
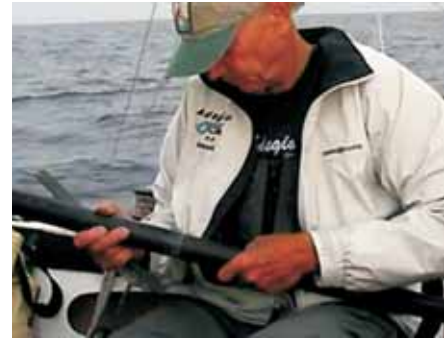
With nothing to lose we started to prepare the remains of the pole by squaring off each broken end about six inches in from the break point, effectively reducing our pole length by one foot. To realign the halves, we fit the two ends using a spare sail batten, making two 18" splints that we stuffed into the hollow ends. We then sanded the sharp edges smooth.

Meade preparing the boom for repair while underway. 1—Squaring the broken end with a hacksaw. 2—Fitting a batten in the broken end. 3—Connecting the broken ends before completing the repair with a WEST SYSTEM Handy Pack, two small bottles of G/5 and some lengths of 1½" Unidirectional Carbon Fiber.

In the main cabin we set up a gluing operation complete with Handy Packs of WEST SYSTEM 105 Epoxy Resin® and 205 Fast Hardener®, and two small bottles of G/5® Five-Minute Adhesive. We laid out lengths of 1½" 702 Unidirectional Carbon Fiber Tape for wet out on a sheet of thin repair plywood (an item we always carry when going offshore). We first wet out two 20" lengths, which we then cut in half and applied to the pole leaving 5" on either side of the butt splice, with the four layers just covering the pole circumference. We applied four more layers like these, each two inches shorter than its predecessor.

The key to success of the operation was mixing 105 Resin/205 Fast Hardener with G/5 resin and hardener in a two-to-one blend.¹ This mixture vastly sped the cure time of 105/205 to 15 minutes working time and a tack free cure of about one hour. With two separate batches we got the job done in about 40 minutes using only a plastic spreader to apply the epoxy and to remove air while the cure progressed on the layers of carbon fiber tape.

At one hour (while still in the green stage) we wrapped the entire carbon splice area with light cordage under tension, both to consolidate the various layers and increase hoop strength.
