Camper panel repair

By Tom Pawlak

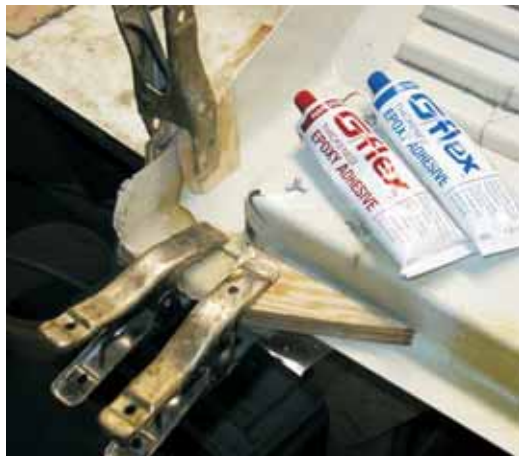
Left—Spacers and weights were used to force the grill into its original shape while the glue cured.

Right—Completed repairs were reinforced on the backside with G/flex 655 and 4 oz fiberglass cloth.

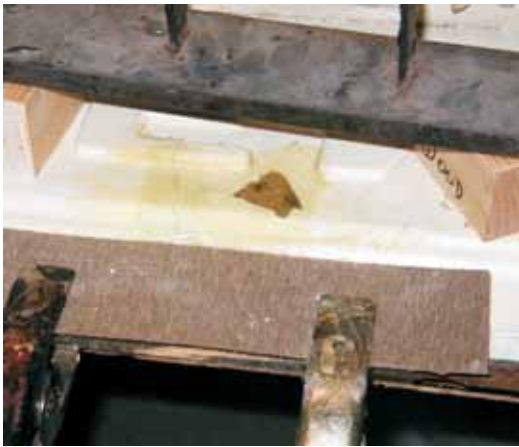
Left—The grill is held against plastic covered plywood with clamps and weights so repairs will be flat and smooth.

Repairing the missing sections required a backer mold to support the epoxy while it cured. Cellophane tape applied to flat plywood panels made an excellent mold and release surface for repairing flat sections of the panel.

The panel had warped slightly, so we weighed it down flat to make good contact with the mold. If we hadn't forced tight contact the cured repair would have required lots of sanding before it could be painted.

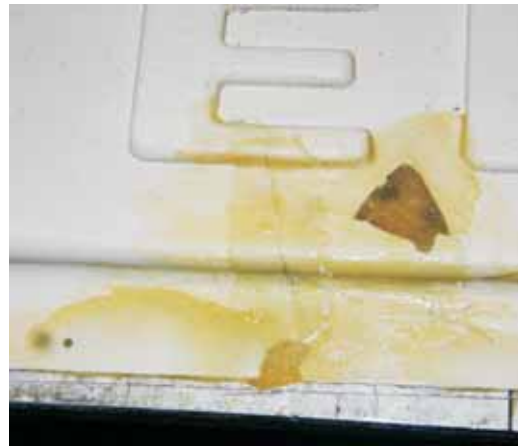
Right—Missing parts and cracks were filled with G/flex 655 and covered with 4 oz cloth.

Many of the holes around the perimeter were cracked and split. To repair these, we ground into and beveled the cracks about 1/2" back with a 2" diameter sanding disk mounted on a drill motor. We filled these dished-out areas with G/flex 655 and before it cured, set in a 1" diameter patch of 4 oz fibreglass cloth.

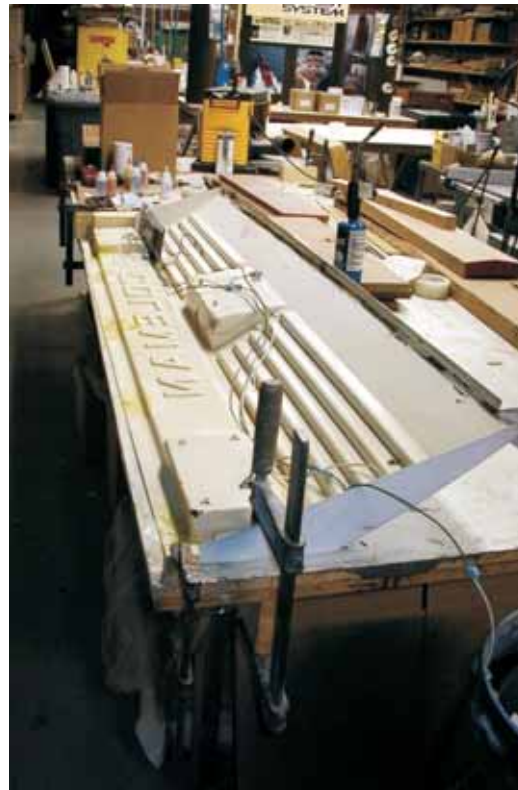
The grill is clamped to remove twist while the repairs are made and the epoxy cures.

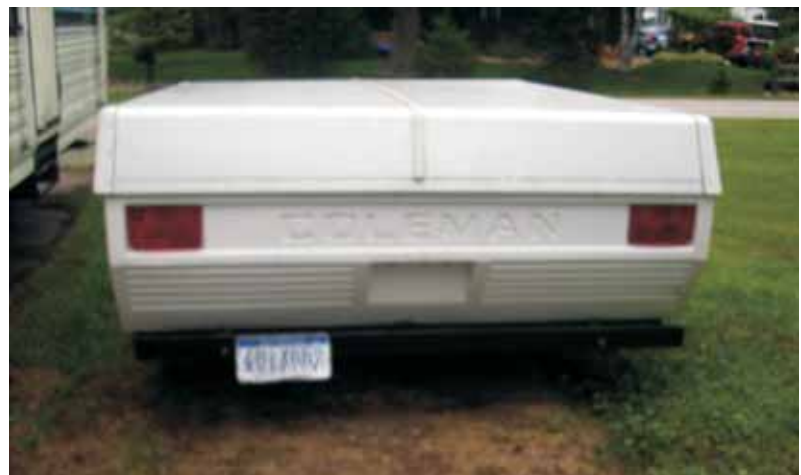
The repaired panel is back in place on the camper. A coat of Krylon Fusion™ textured, plastic-compatible paint completed the repair.

Todd spray painted the repaired panel with white textured Krylon Fusion™ plastic-compatible paint. He reinstalled it and says it now looks brand new. ■
