# Saving the deck

By Jeff Blackmon

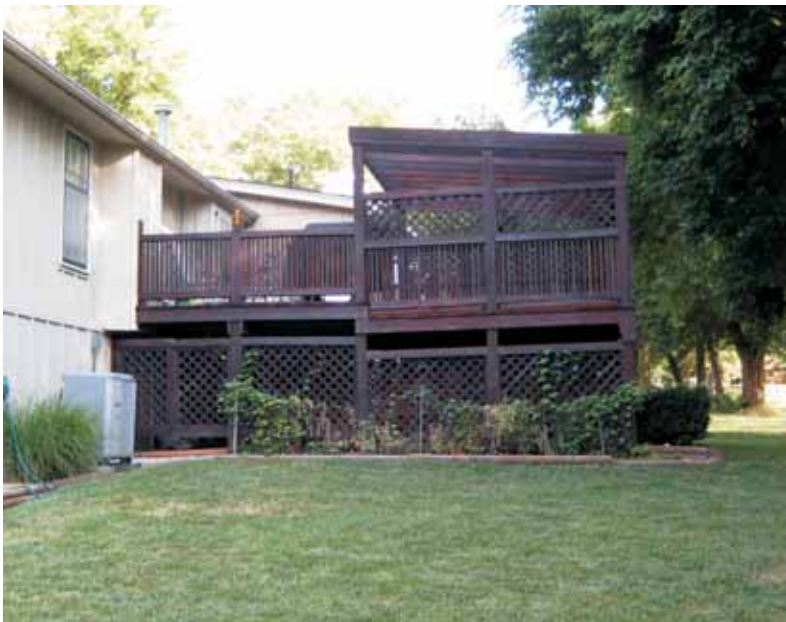
Blackmon's two-story deck is supported by 6×6 redwood posts resting on concrete footings.

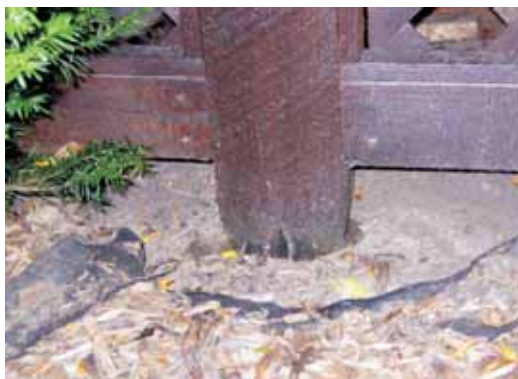
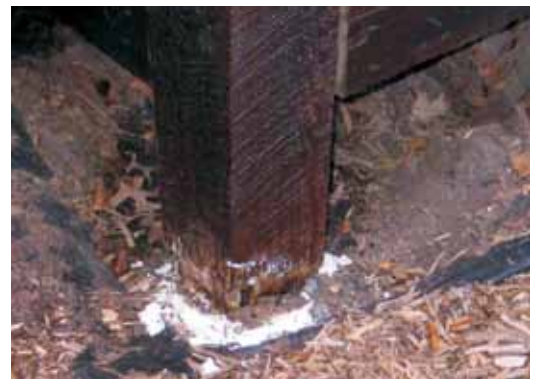
Last spring after power-washing the deck, I began the once-every-three-or-four-years jobs of staining it. This deck is twenty years old now but still holding up well. But as I applied the stain to the 6×6 support posts, I noticed severe wood rot in some of the posts. Over the years I'd neglected proper landscaping around the base of these, which lead to soil surrounding the bottom two or three inches of the posts. This in turn held the moisture near the footings much longer than it should have. The resulting compromise of structural integrity had to be addressed. In some cases, up to 25% of the cross-section of the post had rotted away. My options were to replace the 6×6 support posts, or structurally repair them. I chose to repair instead of replace.

Two of the posts that rotted where their bottom ends rested on footings. Soil held moisture against the bottom of the posts creating an ideal environment for rot.

I cleaned out the wood rot as much as possible using a screwdriver and sometimes just getting my fingers into the voids and pulling out the dead wood. Then I used a wood preservative solution of copper naphthenate (green preservative) to halt the rot's progression. This solution is a spray, but I also poured on directly when possible. This is one of those situations where more is better.

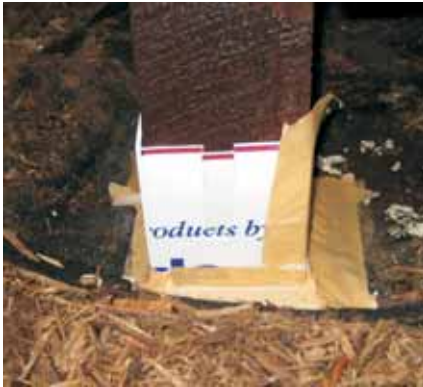
After treating the posts with wood preservative, Blackmon used plastic sign material to make forms around the base of the posts.

Using an expendable plastic sign, I built small forms to fit around the base of the posts. Each form was 2"–4" high based upon the wood rot on the posts. My idea was to pour a replacement base that enclosed the rotted section of the post, and then some of the remaining post. I sprayed the plastic forms with silicone spray in hopes of an easier removal process. Then I carefully taped them

to the original cement footings to hold the poured epoxy inside of the form.

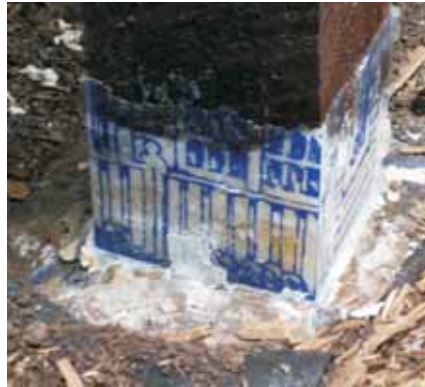
The forms were removed from the cured epoxy revealing the ink that transferred from the inside of the form to the epoxy.

I mixed WEST SYSTEM 105 Resin® with 206 Slow Hardener®. This gave me plenty of time to get the epoxy into the forms. I thickened the mixture with 403 Microfibers, which made it much easier to contain in the forms. Before removing the plastic forms, I let the epoxy cure overnight.

The forms came away from the epoxy with a little work, but the ink from the plastic stayed with the cured epoxy. This wasn't an issue since my next step was to paint the epoxy bases to they blend in with the garden around them. I used a dull brown paint that was created for camouflage work to hide the glossy look of the epoxy.

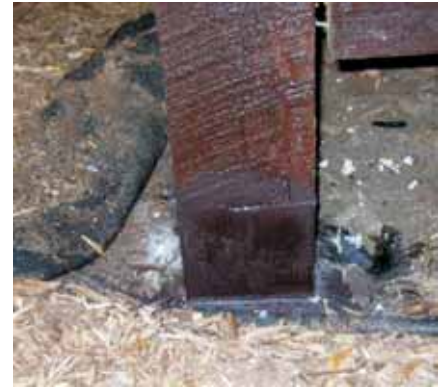
Blackmon finished the repair with a coat of dull brown paint to camouflage the epoxy base.
