Harken® Flexible Furler Repair

By Tami Shelton

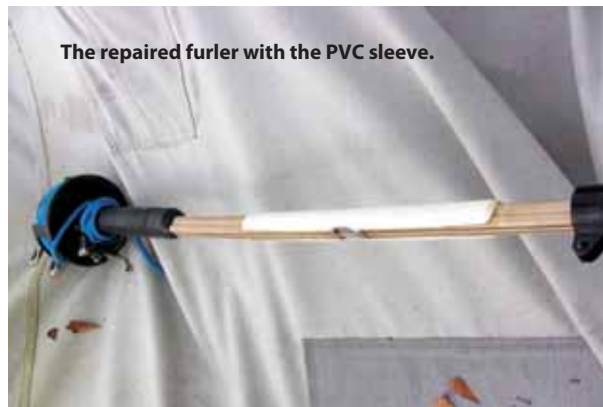
The repaired furler with the PVC sleeve.

I used the pre-thickened G/flex 655 Adhesive for this repair. I mixed up enough to fill the channel in the PVC quite generously and then slipped the PVC over the foil extrusion, centering on the broken area. I allowed excess to ooze out of the gap between the foil and the PVC. I then cleaned up the excess, wrapped the whole repair with wax paper and clamped it into place with a series of spring clamps, one every 2" or so, and allowed it to kick off.

After cure, I spent a fair bit of time cleaning epoxy out of the pre-feeder. I'd had difficulty masking it. In retrospect, it would have been well worth the effort to do a more thorough job of masking things off before gluing. Once I sanded and faired the PVC to the foil extrusion, the repair was complete. The next weekend I took it sailing. ■

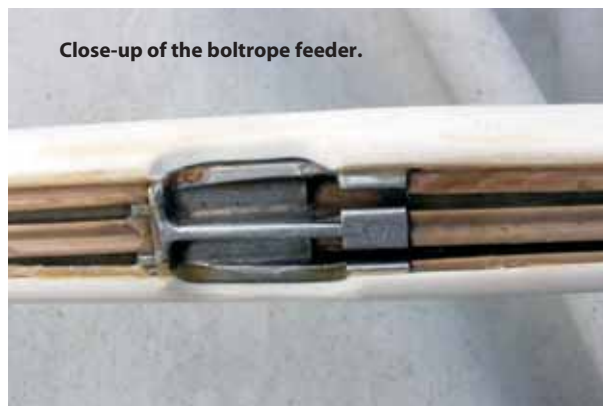
Close-up of the boltrope feeder.

After probably 10-12 years of use, the PVC extrusion failed at the boltrope feeder. The split broke the PVC in two at the feeder, not vertically up the foil, but circumferentially. The liner, and of course the rod rigging, stayed intact. Harken, having discontinued this furler unit, had no solutions to offer.

I prepped the foil extrusion and the inside of the PVC sleeve with the alcohol wipe and flame treatment (see page 18). After this, I masked the boltrope track and pre-feeder with clear packaging tape to prevent epoxy from getting into the track.

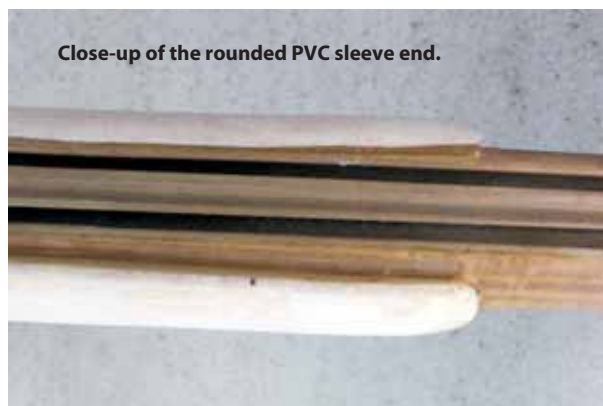
Close-up of the rounded PVC sleeve end.

I first selected a diameter of PVC which was close to that of the foil. I cut a piece of the PVC much longer than I thought necessary to bridge the split, but I was concerned about loads from the furling drum causing another crack beyond the area of repair. With the extra long PVC bridge I hope to reduce bending of the foil around the feeder area.
