Testing for Damage Tolerance

By Jeff Wright

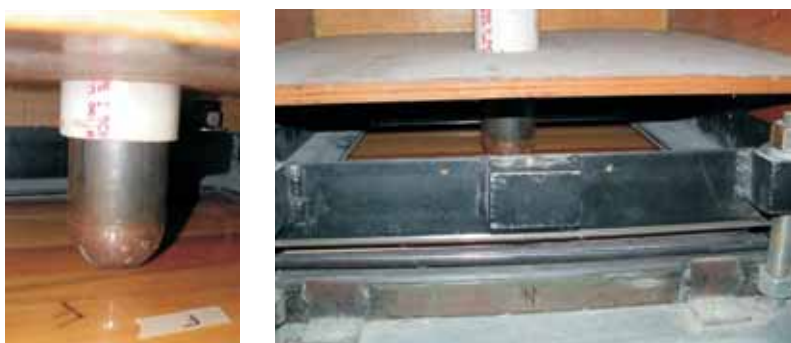
Figure 1a, right—The impact test fixture.

Figure 1b, left—The blunt, semi-spherical end of the 70 lb weight.

The stiffness of the panels would first be measured in accordance with ASTM D-6416. The panels were then damaged using our impact test fixture (*Figure 1a*) which applies the same impact force to a secured panel by dropping a blunt nosed weight (*Figure 1b*) from a fixed distance. After the panels were all struck (and damaged) by the same force, the stiffness would be measured again using the Hydromat to evaluate the effect of the damage.

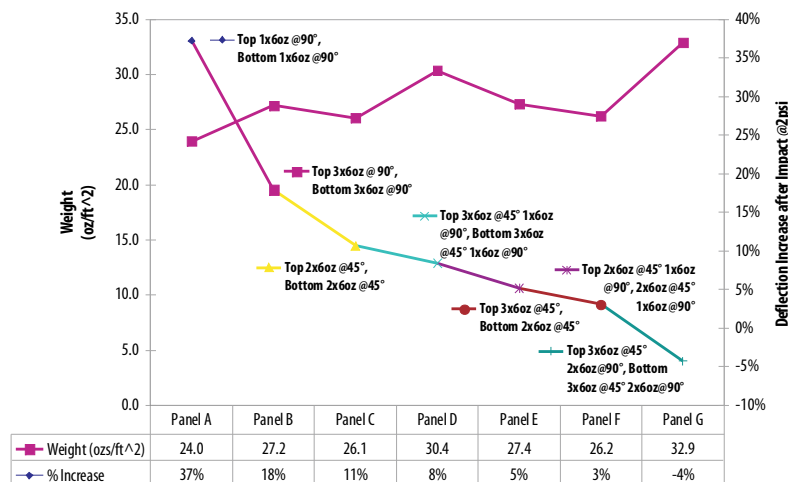
Figure 2—Ted Moore's Panel Impact Testing Results

At first glance, the results seem to indicate that more layers of fiberglass help retain stiffness after an impact, but when fiber orientation is considered, the impact performance can be improved without increasing weight. In *Figure 2*, the increase in deflection when compared to weight is generally lower when the sheathing consists of 45° oriented fibers. Even though the panels are in the shape of a square, the fiber orientation had a significant effect due to the grain direction of the wood strips.

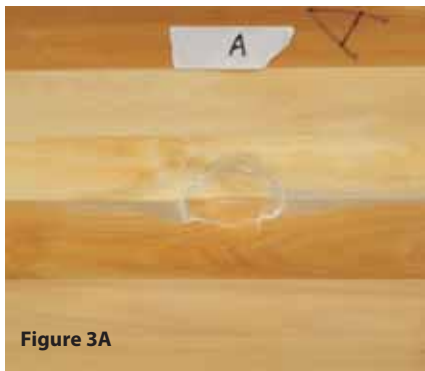
Figure 3A

The pictures of Panel A, one layer of 6oz fiberglass cloth oriented at 90° on each side, show a very small area of damage on the impact side (*Figure 3A*) but the reverse side (*Figure 3B*) has a large laminate failure. Much of the laminate failure occurred in the fibers oriented across the wood grain, indicating that additional cross grain strength would be beneficial. Panel C (*Figure 4A, impact side*

After the test panels were struck, they show a very small area of damage on the impact side but the reverse side has a large laminate failure. Much of the laminate failure occurred in the fibers oriented across the wood grain.

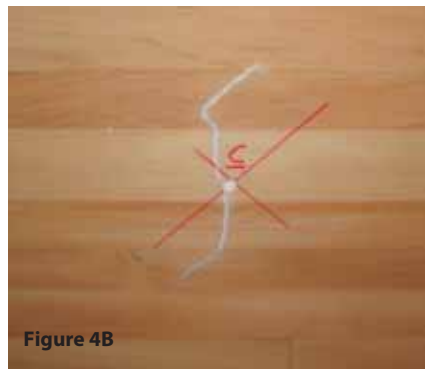
Figure 4B

and 4B, reverse side), which had an additional layer of 6oz cloth on each side oriented 45° to the wood grain, retained significantly more stiffness than Panel A. The other panels with fiberglass oriented at 45° to the wood grain also retained more stiffness than panels with the same amount of fabric oriented at 90° to the wood grain. The combination with the best balance between weight and damage resistance appears to be Panel F (Figure 5a, impact side and 5B, reverse side). It had almost the damage tolerance of Panel G, which did not lose any stiffness from the impact, but Panel F weighs much less.
