The limitations of statues

By W.D. Bertelsen

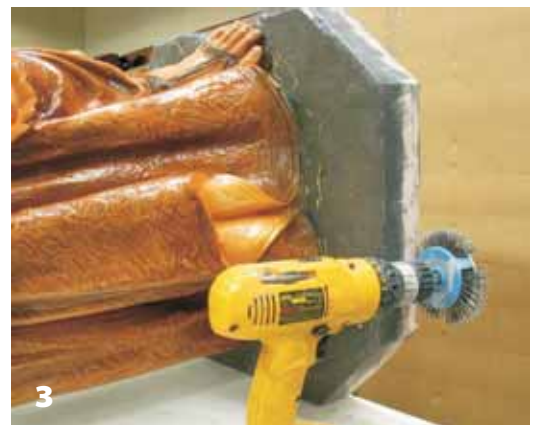
3—The gluing area of the pedestal was prepared for bonding by thoroughly abrading the surface with a wire wheel tool on a cordless drill.
