A quick architectural fix

By Michael Barker

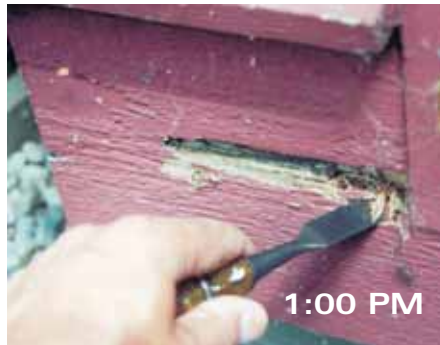
I started by digging out all of the soft, damaged wood. Only a small area of rot showed on the surface, but the cavity of rotted wood behind the paint was larger. A small chisel and a Swiss Army knife took care of the rotted wood.

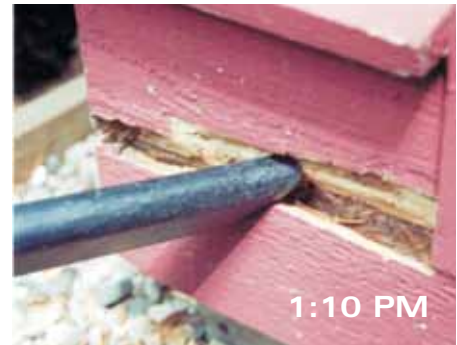
After digging and scraping down to solid wood, all of the loose material was vacuumed out of the cavity. I was prepared to dry out the cavity with a hair dryer, but was surprised to find the wood in the cavity dry.

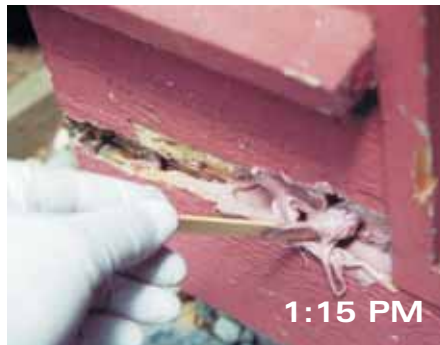
I filled the cavity with 105/205 (fast hardener), thickened with 407 Low-Density and 406 Colloidal Silica. I worked the mixture into all of the voids and filled it slightly higher than the wood surface.

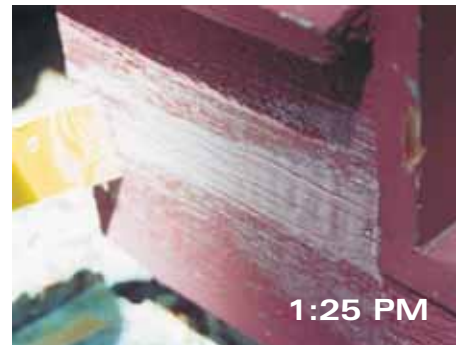
One key to making this repair quickly is the board's roughsawn texture. I dragged a plastic spreader, with the edge scuffed up, over the thickened epoxy, simulating the wood's texture.

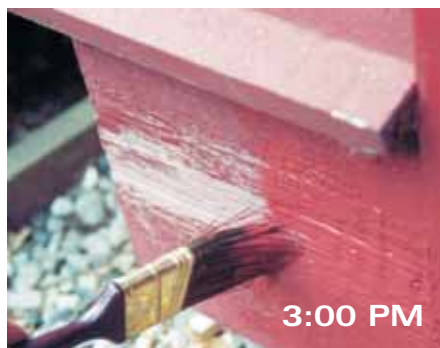
After an hour and a half in the warm temperature, the epoxy had firmed up, but was still slightly tacky. The epoxy texture blended pretty well with the roughsawn wood, so no sanding or other preparation was necessary. I applied one heavy coat of matching latex paint.

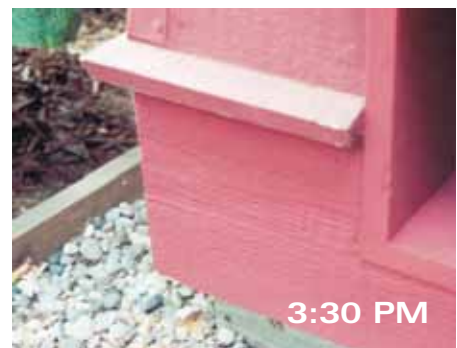
Half an hour later the paint had dried, even though the epoxy was still curing underneath. The epoxy never shrank or otherwise affected the paint's adhesion. The repair was essentially complete in two and a half hours, with about a half an hour of actual work.
