Readers' plumbing projects

Emergency pump repair

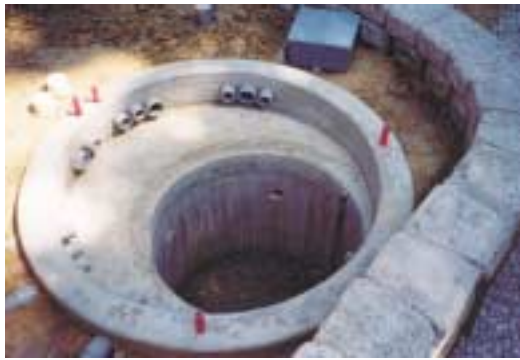
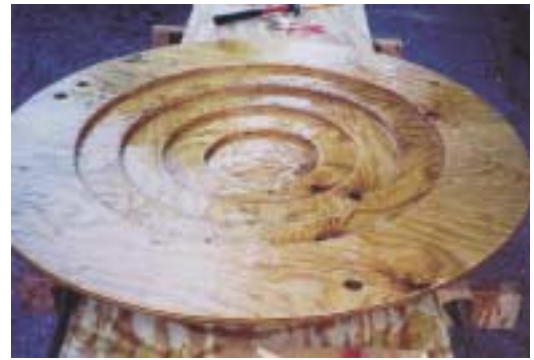
Richard Jobe was faced with having a sump (above, left) located in the middle of a prominent landscaped area in front of his Newburgh, Indiana home. His solution was to build a cover (above, right) for the sump that would be light enough for one person to handle, strong enough to hold the weight of half a foot of pea stone, and water resistant enough to survive being buried underground. The cover is made from one sheet of 3/4" plywood, glued together and well coated with WEST SYSTEM® epoxy. The sump will be hidden under the landscaping (right), but accessible, if necessary, by raking back the pea stone.

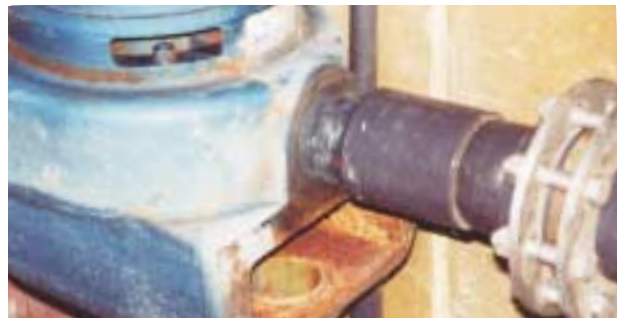
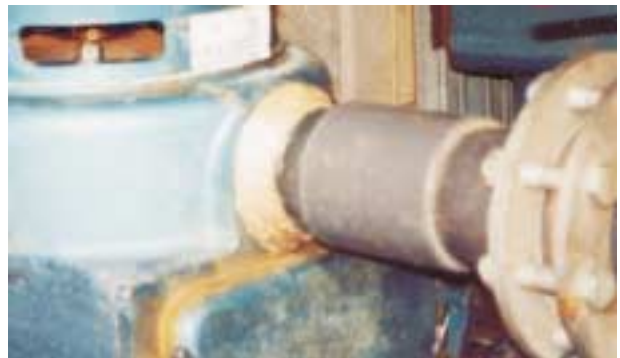
Barry Bew, a sailing instructor at Arethusa Venture Centre, Gravesend, Kent, UK, used his experience as a plant engineer to make an emergency repair to a swimming pool circulating pump. The pump was leaking at joints between the 3" ABS plastic inlet and discharge pipes and the cast iron pump body.

Barry cleaned up both bonding surfaces by grinding down to clean metal on the cast iron, down to clean plastic on the ABS pipes contaminated by thread sealant. He flame treated the ABS bonding surface following the recommendation in *Epoxyworks 16* and on the westsystem.com website. He also applied a coat of unthickened epoxy to the cast iron bonding surfaces, then [wet] sanded the fresh epoxy into the surface.

Barry first applied a small fillet, with a minimum amount of filler added, around the joints. After the small fillet gelled, he applied a larger, thicker fillet around the joints. He allowed the epoxy to cure for 72 hours, keeping the cast iron warm with a fan heater, before pressurizing the joints. The pump's output pressure is 15 psi. Barry reports the repair was still 100% effective four months later. ■
