Bolero

Restored

By Joe Parker

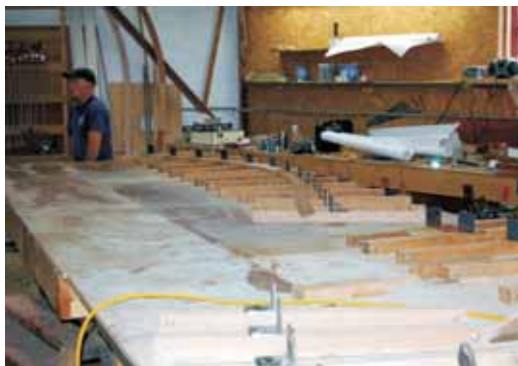
Left—The frame laminating jig. Note the adjustable stops set to create the shape of a frame.

The entire hull skeleton was rebuilt with laminated white oak frames. These frames were glued with WEST SYSTEM Epoxy. G/flex works exceptionally well with white oak, a notoriously difficult to bond wood. Our tech staff worked with the Rockport crew to define the best processes to machine and glue up these large frames and structural components. The white oak stock was milled to 1/4" (6.3 mm) thick, then sanded with 80-grit and wiped with alcohol and a paper towel prior to assembly.

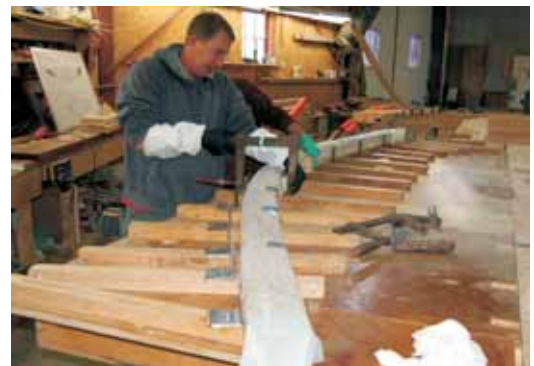
Right—A frame being glued up in the jig. The glued and stacked frame laminations are wrapped in plastic to prevent bonding to the jig.

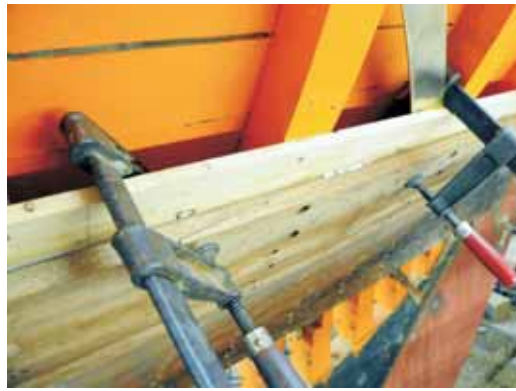
A "nibbed scarf" joint in the outer planking being glued together in place over the inner planking.

Once the skeleton was rebuilt, the hull planking was replaced. Inner planking is white cedar and the outer planking is Sipo, an Indonesian mahogany. The hull planking was glued together with WEST SYSTEM 105/206. All planking was scarfed with a locking or nibbed scarf and glued in place on the hull. This type of scarf is great in thicker stock to help align the scarf and prevent under or over matching the scarf bevels.

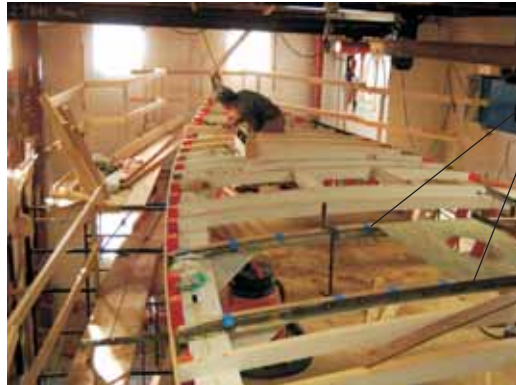
Deck frames being installed with the Monel weldment visible.

the ballast keel, mast step, mast partners, two deck beams and the chainplates. This structure is still in great condition and was left in place while the framing members were replaced around it. You can see the deck section of the weldment in second photo at left.

The deck is framed with laminated white oak glued up with G/flex for the main beams. The smaller frames are laminated spruce glued up with 105/205. The deck is a 4-layer composite to allow for a traditional looking overhead on the inside of the boat and a traditional looking planked deck on the top side. The first layer is tongue and groove Alaskan white cedar laid fore and aft and glued up with 105/206. Then two plies of 1/4" (6.3 mm) Meranti plywood are laminated with 105/206 and vacuum bagged onto that. The final layer is planked fore and aft with Alaskan white cedar and left natural on the top surface for a very traditional look and feel. The deck beams were laminated on the bench and then assembled on the hull framing. The deck house was also re-worked and installed as a complete structure.

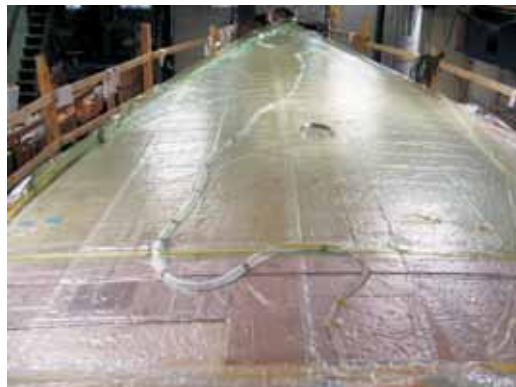
Two layers of 1/4" plywood are vacuum bagged over cedar planking. Note the staggered joints in the plies.

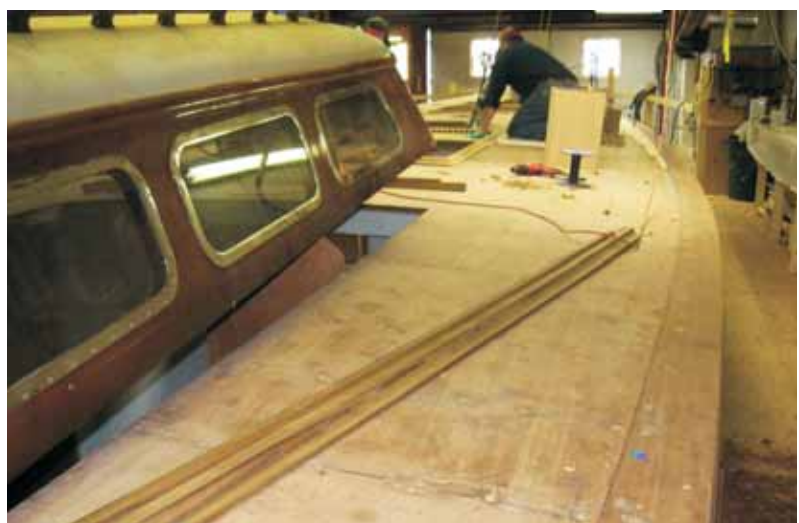
The deck house being fitted to the new deck.
