# EPOXYWORKS®

BUILDING, RESTORATION & REPAIR with EPOXY  
Number 54 ■ Spring 2022

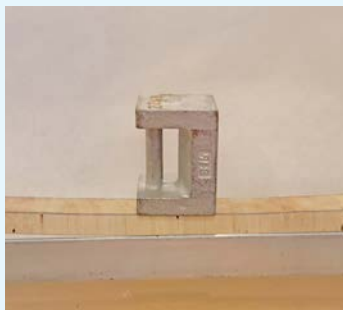
The balsa cored control sample deflected the most.

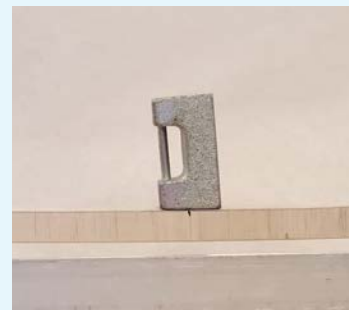
The end grain pine repair was only a little stiffer.

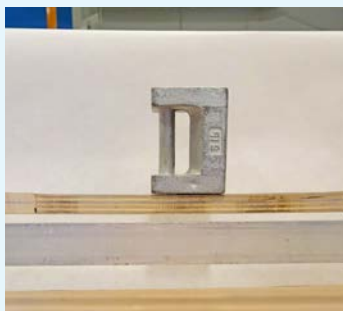
The plywood repair stayed flat across its one-foot section and bent upward at the joint.

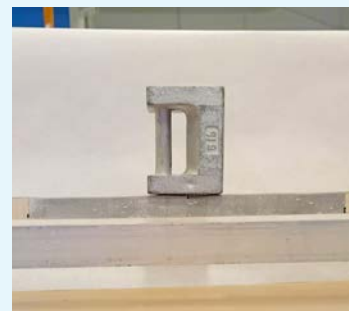
Epoxy filled core repair performed similar to the plywood but was slightly stiffer.

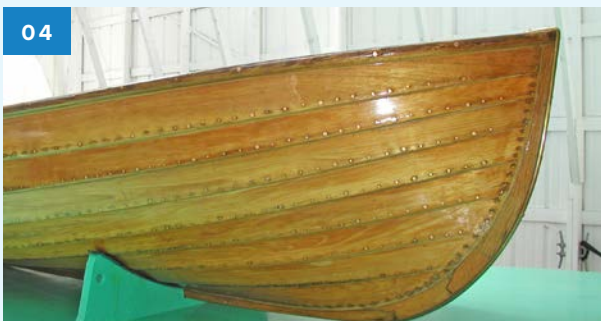
There were small checks in the planks joining the transom and keel. The keel had minor grounding damage. I simply reefed the checks slightly with my pocketknife and filled them with WEST SYSTEM 105/205 thickened with 404 filler.

I used WEST SYSTEM 105/205 to wet out the wood, then added 404 filler to install graving pieces and fills. I used 105/207 on the exterior hull to seal the wood, and then varnished it.

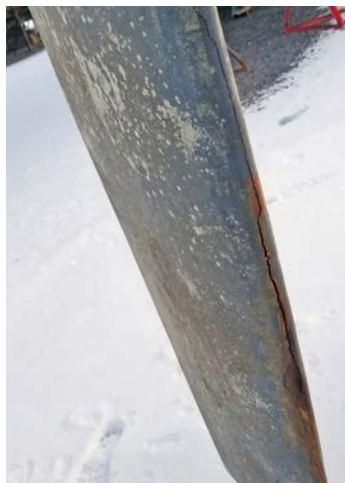
We found two smaller delaminated spots on one side of the rudder and a sizeable one on the other, along with a 6" crack near the rudder shaft. After drilling a few  $\frac{3}{8}$ " drainage holes through the fiberglass skin and into the foam core, we saw that it was still in good shape even though the foam was wet.

**BOTTOM:**  
*The cracked fiberglass rudder.*

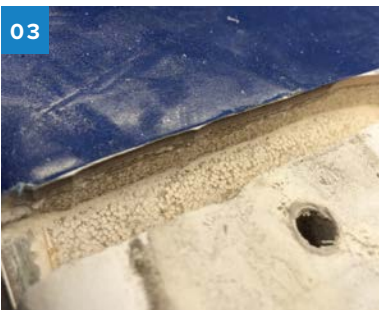
The first step in this repair was to find out why the laminate had been compressed to the point of failure. To investigate, I removed the aluminum mast brackets from the mast step

*The aluminum brackets were removed to evaluate the damage.*

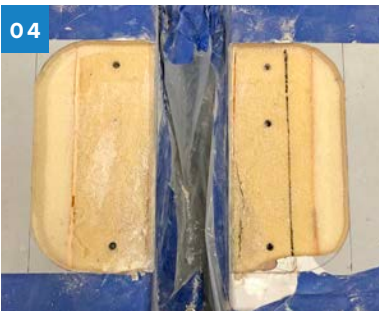
and examined how the deck was constructed. Using a router with a plunge tip bit cutter, I removed a portion of the deck but left the inner fiberglass skin intact. This made the problem easy to see: the laminate damage occurred because the load was too great for the core.

The deck had been fabricated with a few layers of lightweight fiberglass over high-density foam core, with minimal layers of fiberglass inside of the hull. The high loads from the mast bearing down on the aluminum mast step had compressed the foam core, leading to fatigue damage over the years.

*A router was the best tool for removing the high-density foam core.*

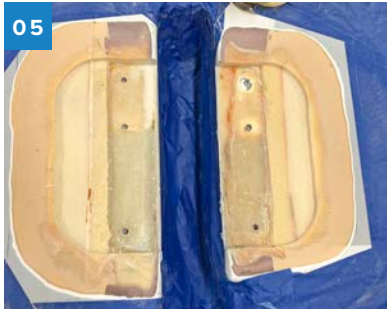
*To make room for the G-10 panel, I removed the high-density foam with a router.*

I devised a two-part repair plan that would prevent this failure from reoccurring. First part required increasing the compression strength of the core. Second part was to strengthen the supporting structure to redistribute loads to the hull.

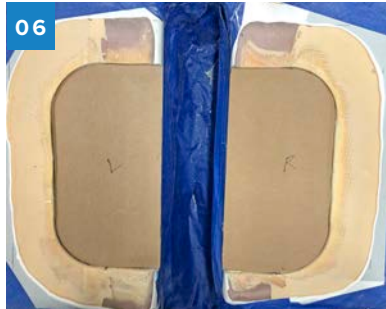
The fiberglass laminate was beveled around the perimeter of the cutout area. The foam was removed under the G-10 panel although some foam remained when this image was taken.

After the Six10® cured, I used a grinder to taper a 12:1 bevel around the perimeter of the outer fiberglass skin on the deck. In order to replace the damaged laminate, I cut five patches of 1708 biaxial fiberglass cloth in graduating sizes. I used WEST SYSTEM® 105 Resin and 206 Slow Hardener® to apply these patches. I made each fiberglass patch ½" smaller in all directions. I wet out the patches with epoxy and applied the largest patch first, followed by four consecutively smaller patches to match the original thickness. I then applied 2-3 fill coats of epoxy.

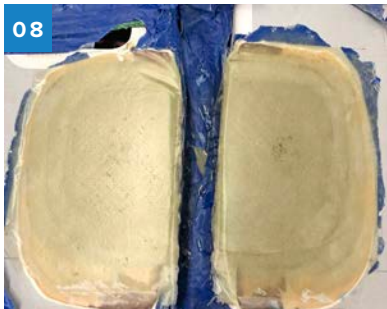
5/8" G-10 panels were bonded to the deck with Six10 Thickened Epoxy Adhesive.

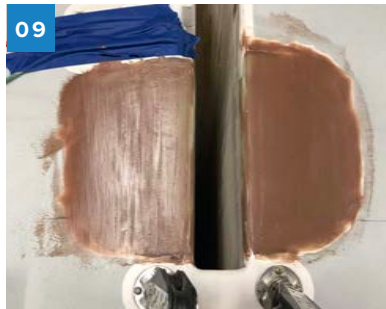
Four layers of 1708 biaxial cloth was applied over the G-10 panels.

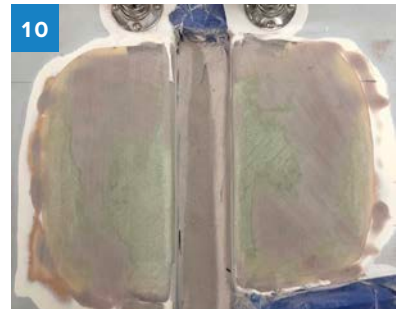
WEST SYSTEM 105/206 thickened with 407 Low-Density filler was used to fair the repair with the existing deck.

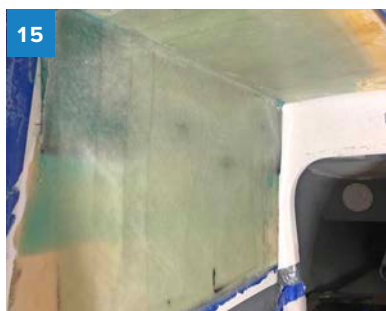
The G-10 panel bonded to the underside of the deck and the 1/4" thick fiberglass panel bonded to the daggerboard case. Prop sticks helped to hold the panel into position until the Six10 cured.

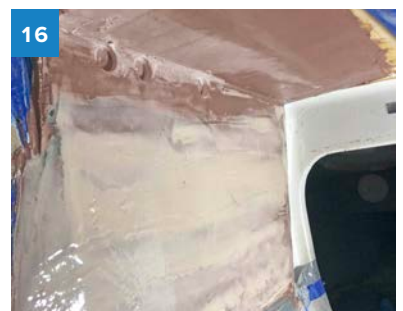
Four layers of 1708 were applied over the panels with 105/206.

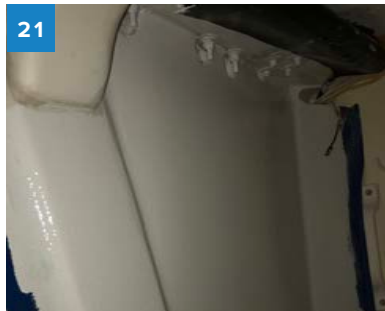
*The port side G-10 panel was bonded underneath the deck with Six10.*

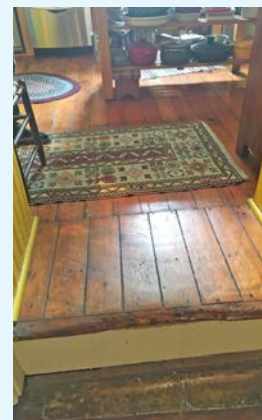
The Kitchen threshold, repaired.
